Abbotts Hall Managed Realignment Scheme (England)

Case Study

March 2011

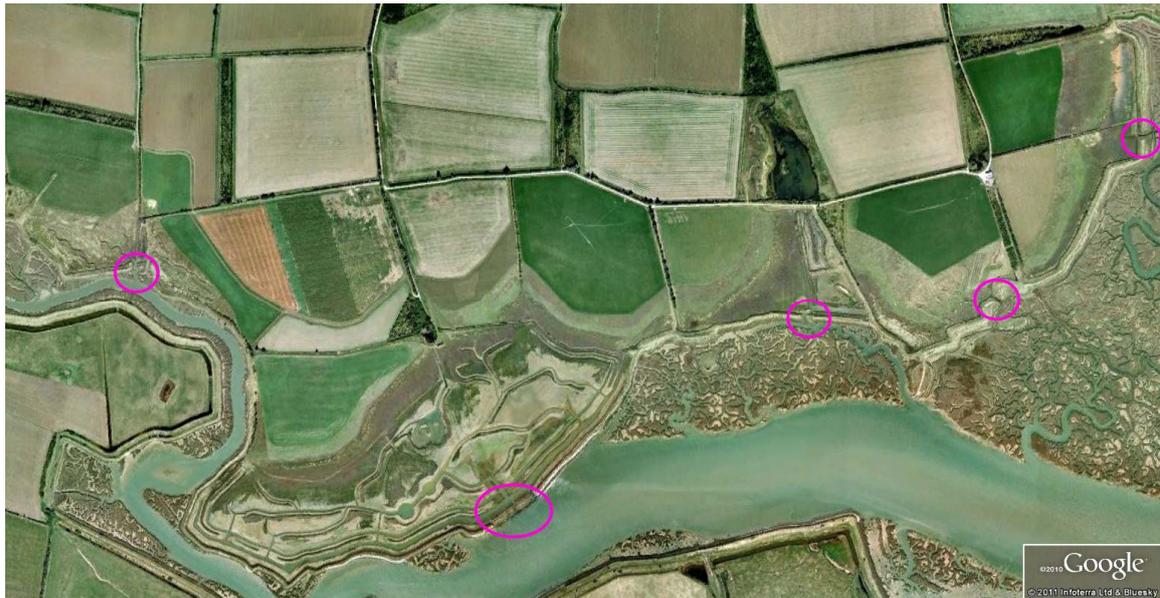
Plate 1. The managed realignment at Abbotts Hall (shortly after first inundation; breaches circled in pink) - Google Earth derived aerial view

The scheme required five breaches in some 3km of hard defences to achieve inundation of the area available (ca. 49ha of the 85ha scheme is intertidal). The largest breach was 100m wide; with a level of +1.5mOD (about MHWN). The four other breaches were smaller being 10-20m in width at higher levels, and all included channels cut through the breach (3-4m in width) to a lower level to facilitate drainage. The main breach was included to moderate outflow; it acted as a sill, restricting the tidal prism of the site and controlling the phasing of the exchange between the site and Salcott Creek (personal communication, HR Wallingford). As the scheme is largely to rising ground, only a 400m section of new embankment needed to be constructed.

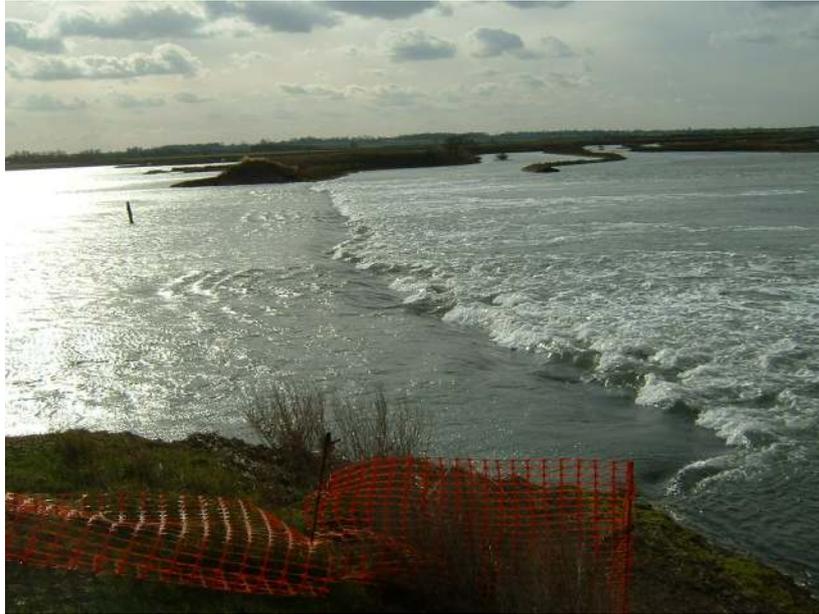
Plate 2. Water flowing into the site through the main breach
