Beneficial Use of Dredged Sediment to Improve Boiler Marsh, Lymington (Year 2)

Review of restoration activities and monitoring undertaken for the second trial campaign in 2025

January 2026

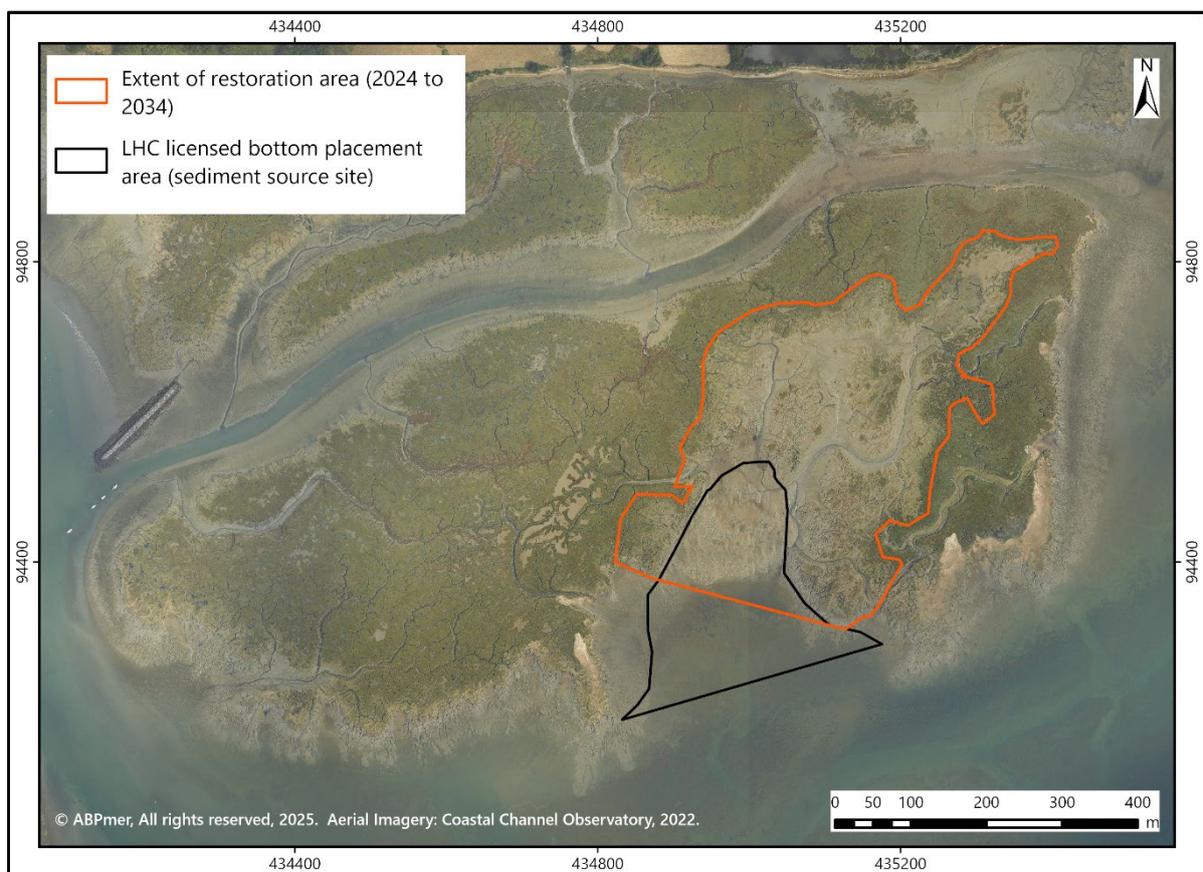
Figure 2. Areas on Boiler Marsh licensed for bottom placement and restoration

For the new marsh restoration project (under L/2023/00294/1), some of this deposited and now consolidated dredge sediment is being moved from the placement site to higher intertidal areas. More details about these two phases in each of these two phases are provided in the following sections.

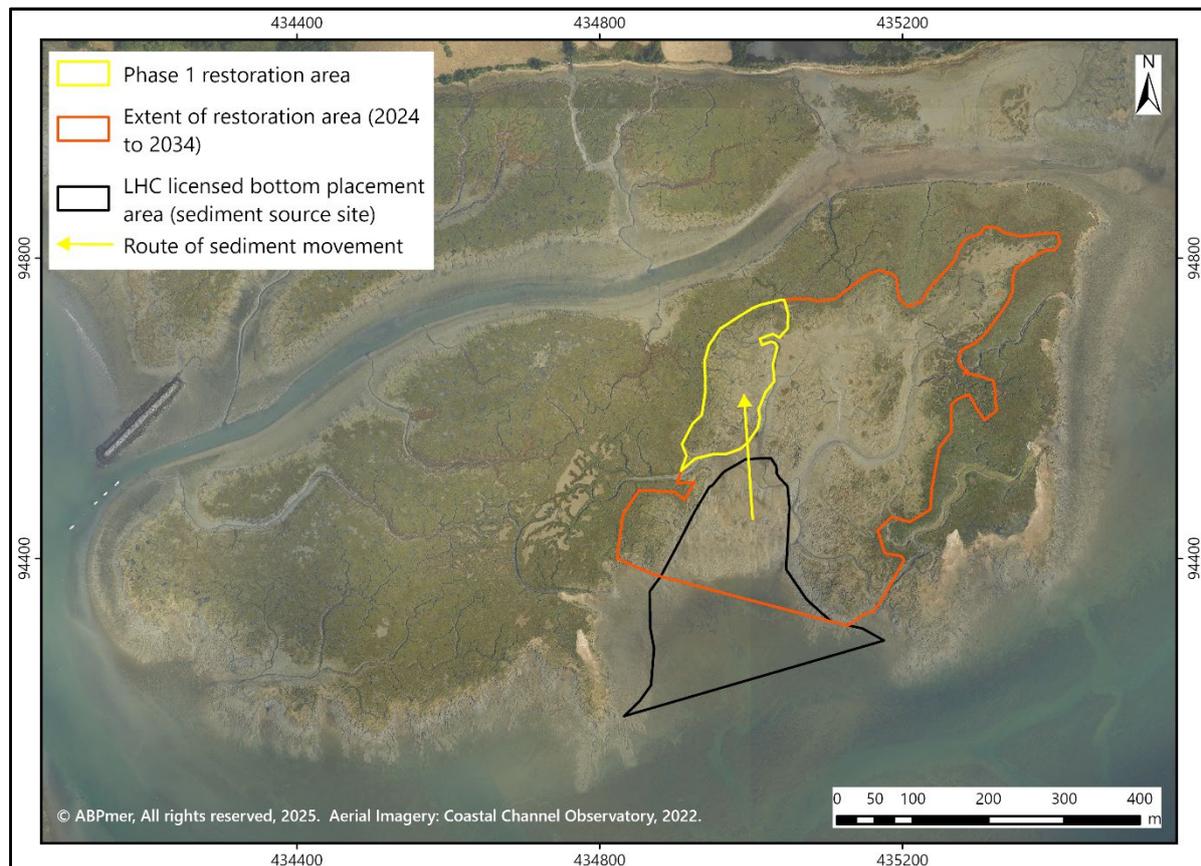
Figure 3. Route of sediment movement for the Phase 1 trial (2024)

During this first trial, several difficulties and delays were encountered which limited how much sediment was moved. The issues included bad weather conditions, strain on the equipment and a relatively short working window. As a result, the amount of bed raising was a lot lower than planned. Only 1,647 m³ was moved as compared with 9,000 m³ which had been the target. Most of that sediment was moved in the last few days of the working window once early difficulties had been overcome.

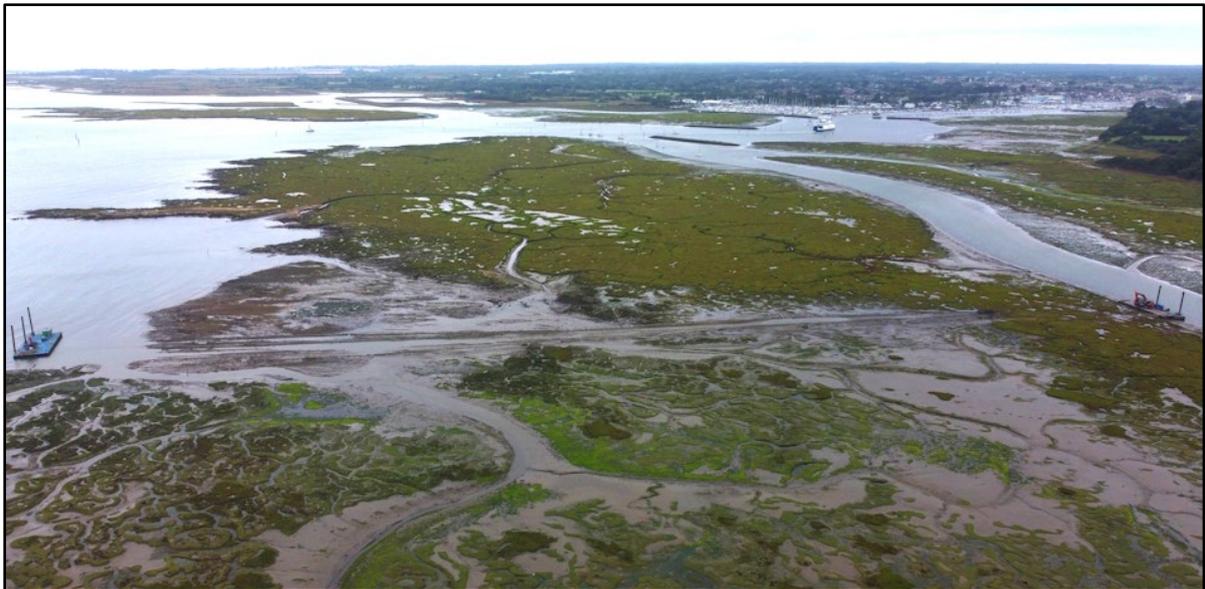
Image 2. Central and west side of Boiler Marsh during Phase 1 drag box activities

It was expected that much of this area could be suitable for saltmarsh plant growth although the extent of such growth was dependent on the mound’s exposure and on how the sediment settled in the months that followed. This is discussed further in Section 3.2.

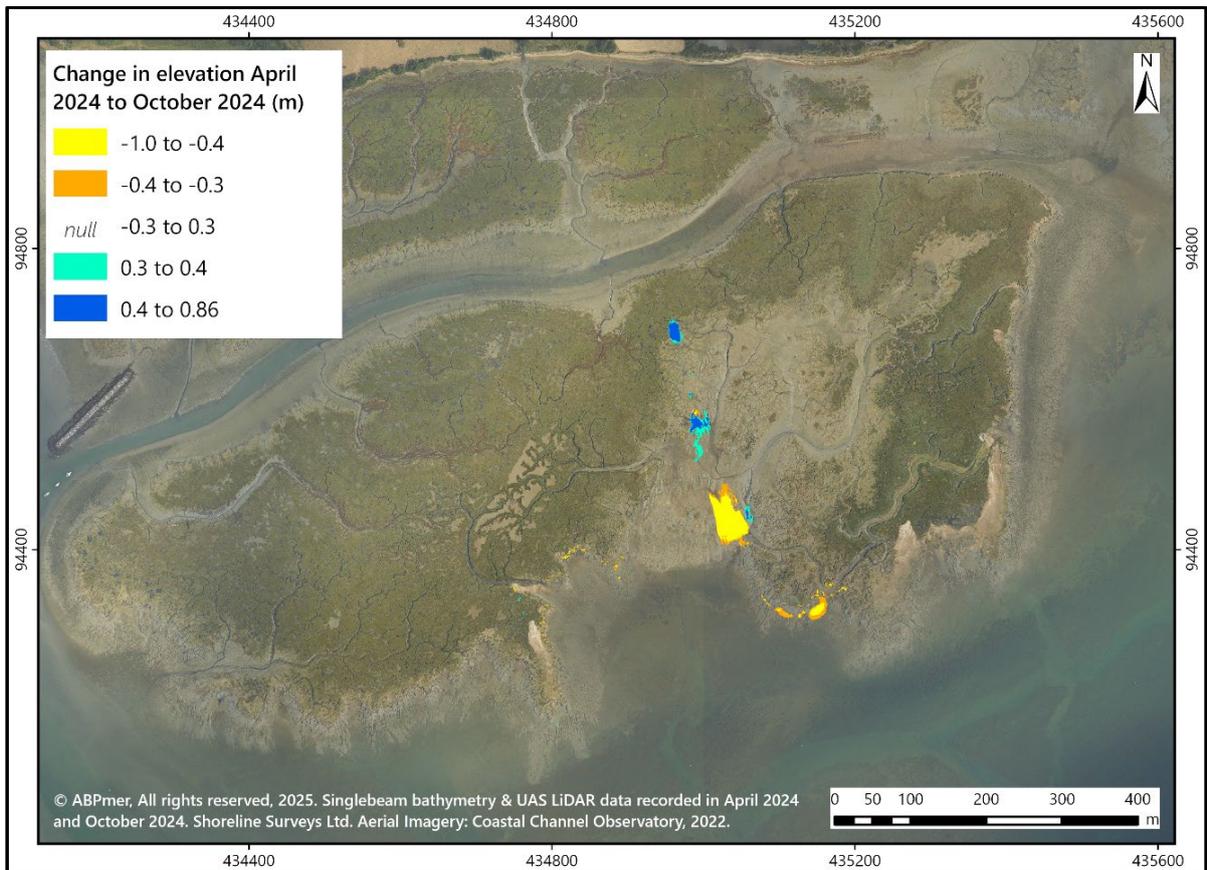
Figure 4. Changes in bed elevation across between April and October 2024

On completion of this Phase 1 stage, two raised mounds were created. These two areas, as well as the regions where the excavation occurred, are illustrated in Figure 4. This figure shows the net changes in bed elevation before (April 2024) and then after (October 2024) this first trial. The highest mound, in the northernmost corner of the restoration area was raised up to a maximum height of 1.62 m ODN (or 3.6 m CD). This raised the intertidal to 0.5 m above the MHWS elevation.

³ Across the whole Phase 1 working areas 0.56 hectare (ha) of intertidal habitat was raised above baseline levels. This area of net change (which does not take account of the height reached by the sediment) is a useful and objective extra measure of the extent of change achieved on this occasion.

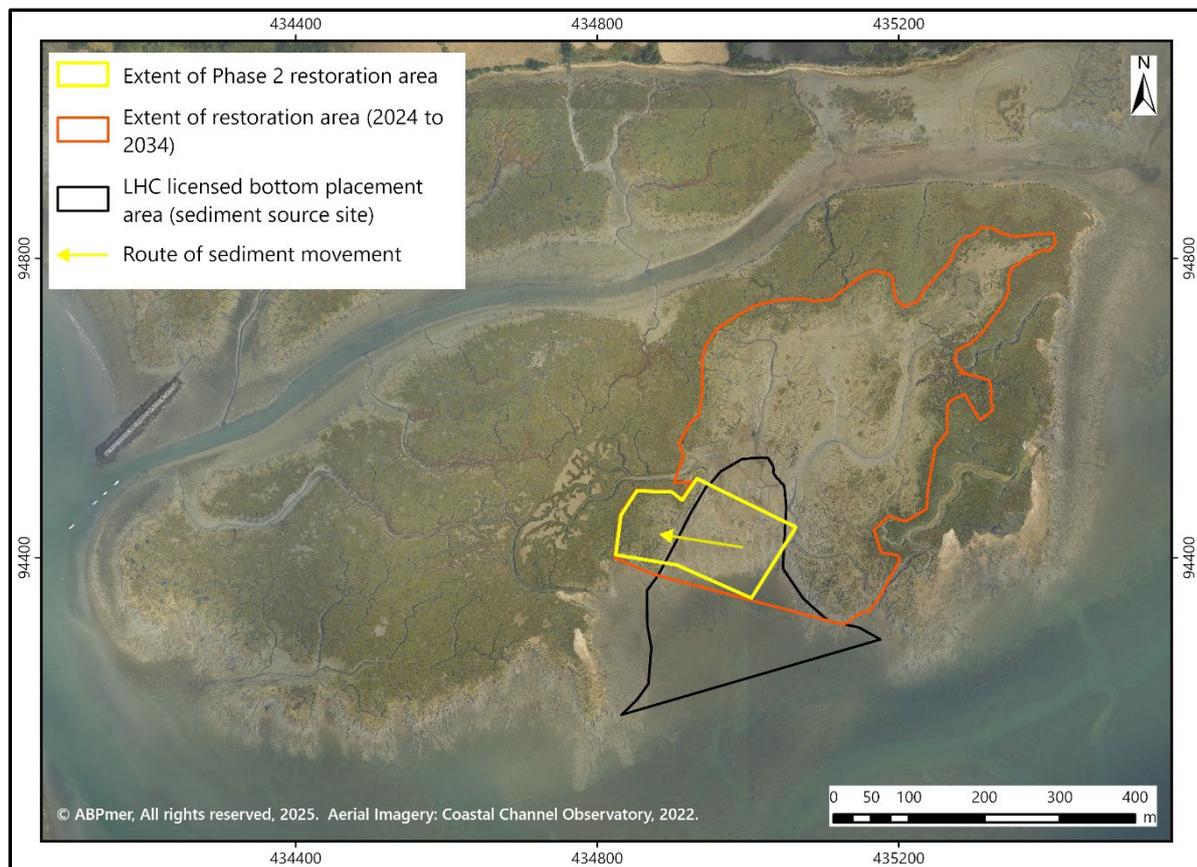
Figure 5. Route of sediment movement for the Phase 2 trial (2025)

The second phase was carried out from 18 August to 19 September 2025 again using the SRDB approach. Allowing for periods of mobilisation and demobilisation the period when the drag box was operation was between 28 August and 14 September. The area where this took place is also shown in Figure 5. As shown on this figure the sediment on this occasion was moved a shorter distance just to the west of the 'bottom placement' ground.

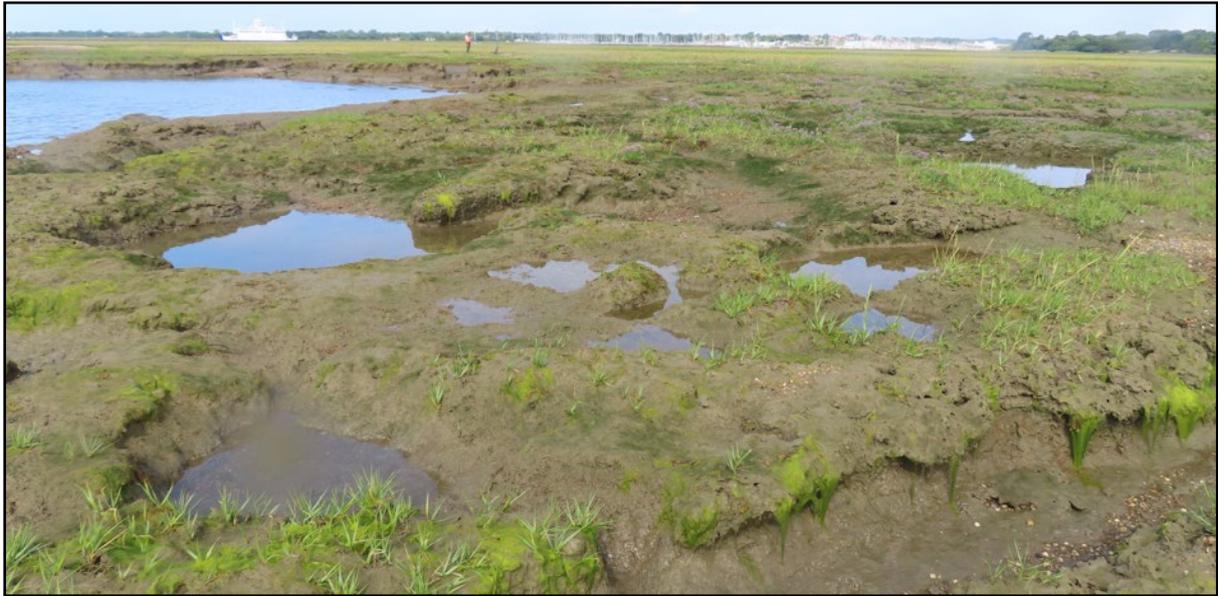
Image 3. Habitats in and around Phase 2 sediment placement area (from Site 4)

The receiving ground for the sediment placement for this Phase 2 trial was an area of still partially vegetated but deteriorating saltmarsh habitat. This deteriorating habitat is shown in Image 3 and Image 4 which were taken from two of the established fixed-point photography locations (Sites 4 and 5 respectively).

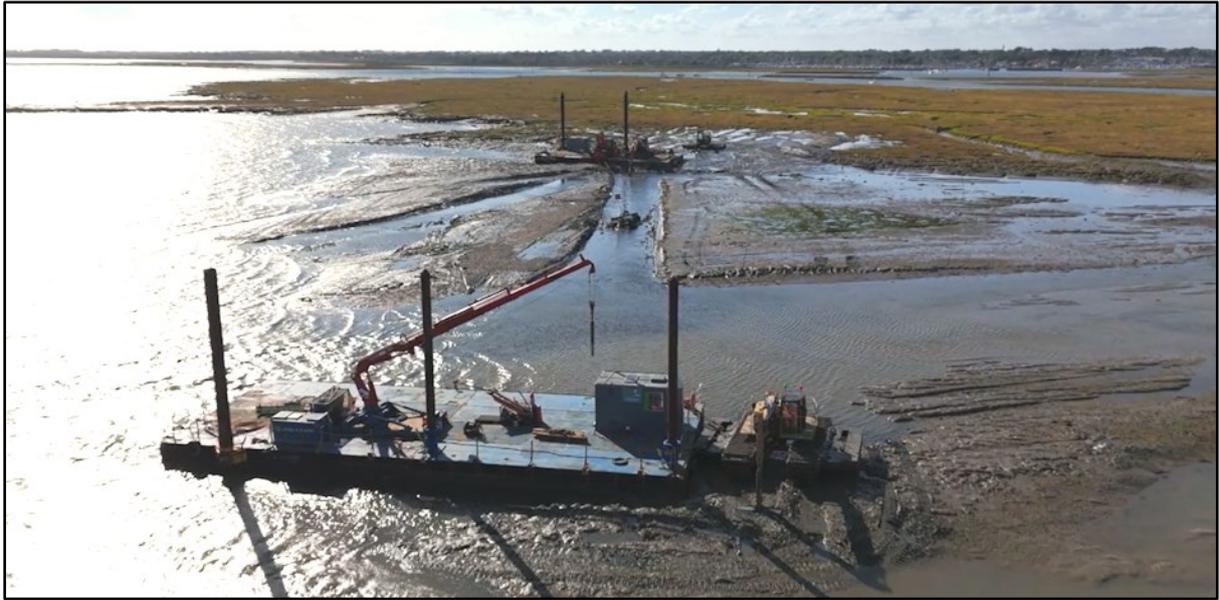
Image 5. Saltmarsh drag box and excavator operations during Phase 2

The SRDB operations during this Phase 2 campaign are also shown in Image 5 and Image 6. As can be seen in these photographs, the work during this campaign involved three separate components. Firstly, the drag box was used to move sediment towards the pontoon closest to the receiving ground. Then a long-reach excavator mounted on this pontoon moved that sediment from one side of the pontoon to the other. Finally, an amphibious 'excavator moved and shaped the material over the donor site. The outcome of this work is described in Section 3. More details about this project can also be found on the ABPmer OMReg site at <https://www.omreg.net/query-database/0066-boiler-marsh-intertidal-relocation/>.

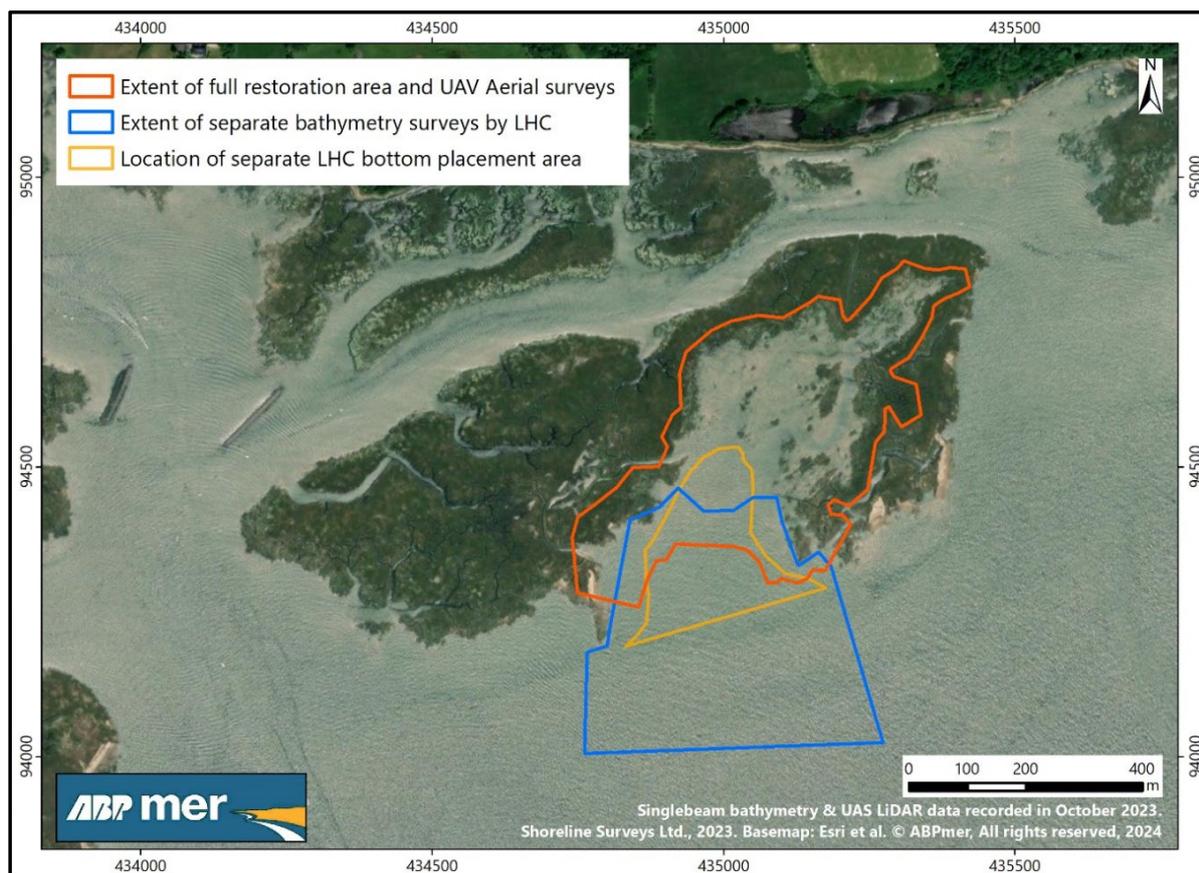
Figure 6. Areas covered by the topography and bathymetry surveys

To evaluate the changes to intertidal bed elevations, Shoreline Surveys Ltd. carried out combined bathymetry and aerial/drone topographic surveys. These surveys were undertaken prior to the works on 12 February 2025 and 27 March 2025 (baseline) and then shortly after the Phase 2 works were completed on 22 September 2025.

The areas covered by these bathymetry and topography surveys encompassed both the dredge sediment placement site from which sediment was excavated and the restoration area where this sediment was moved to. The areas are shown in Figure 6 alongside the area which is licensed for separate bottom placement⁴.

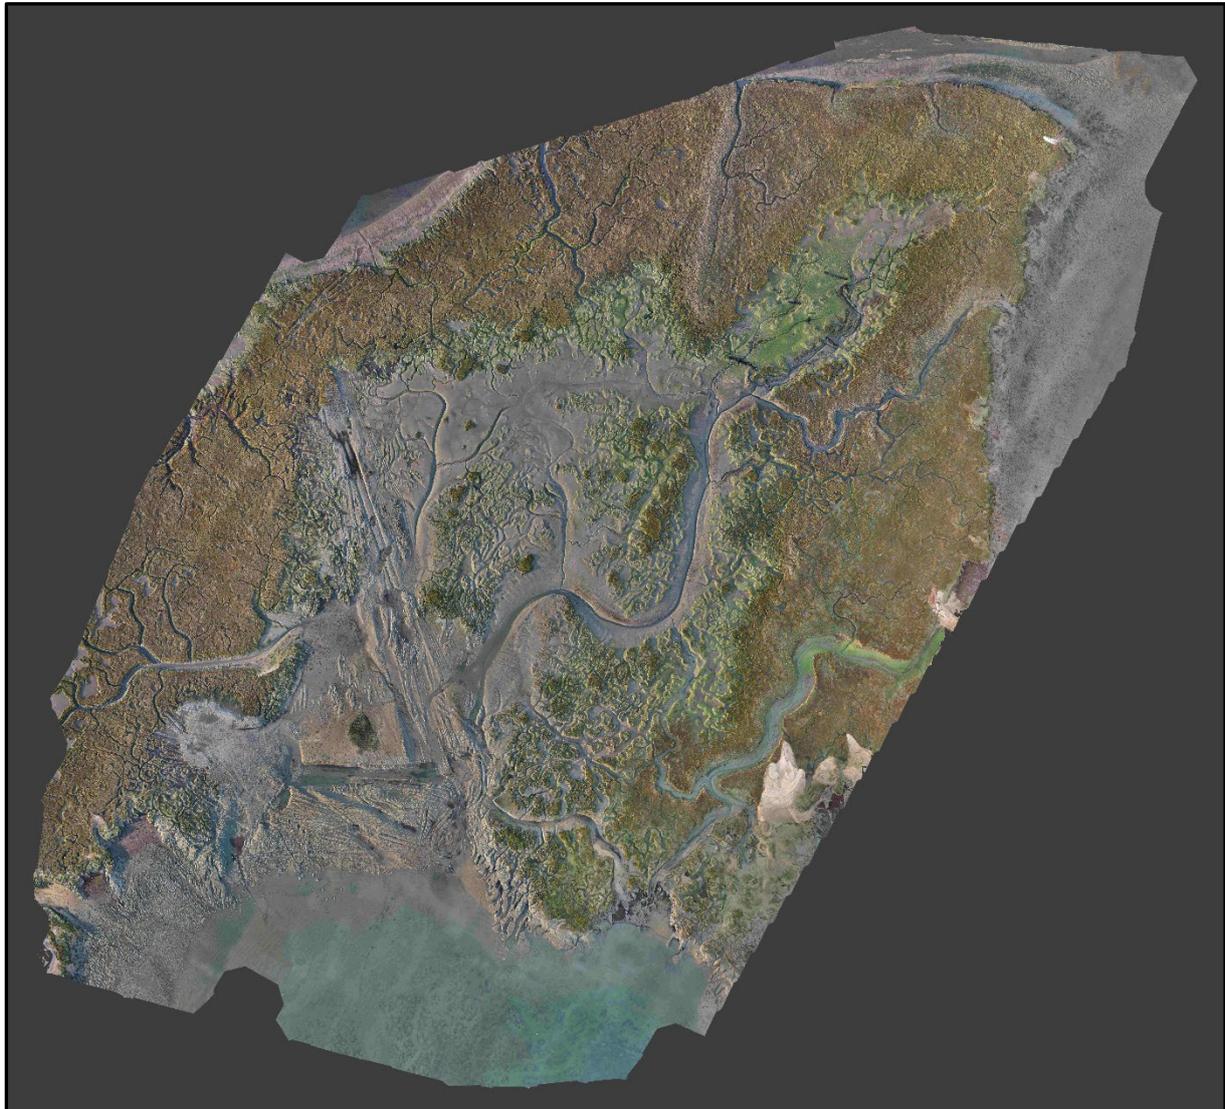
Image 7. Eastern side of Boiler Marsh after completion of the Phase 2 campaign

In addition to this bed elevation monitoring work, Shoreline Surveys Ltd produced a detailed aerial, image of the eastern side of Boiler Marsh. This is shown as Image 7. This image very effectively covers and describes the Phase 1 and Phase 2 working areas. It also provides an up-to-date illustration of the extent of the surrounding marshes.

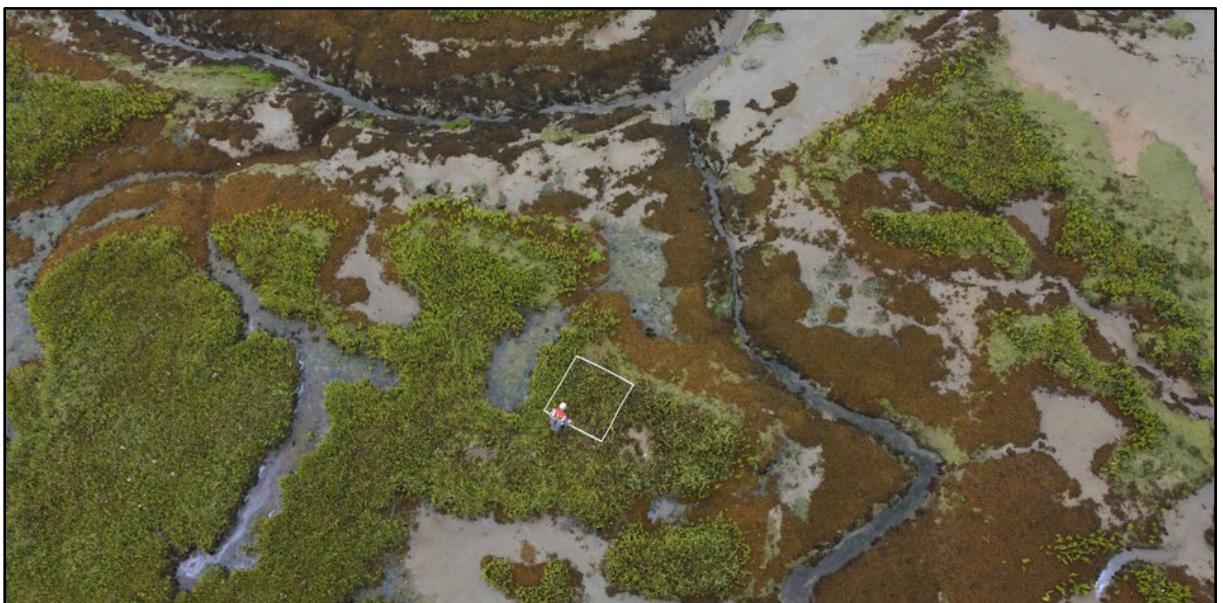
Image 9. Aerial view of 4 m² quadrat site for recording saltmarsh plant cover

At these quadrat locations, a record was taken of percentage cover of each plant species present. Also, the position and bed elevation of each quadrat corner was taken using RTK GPS (see Image 8). These RTK measurements provide information on the range of bed elevations at each site and will also be used in future years to both record and accurately relocate the quadrat locations. An example of a quadrat sampling site is also shown in Image 9.

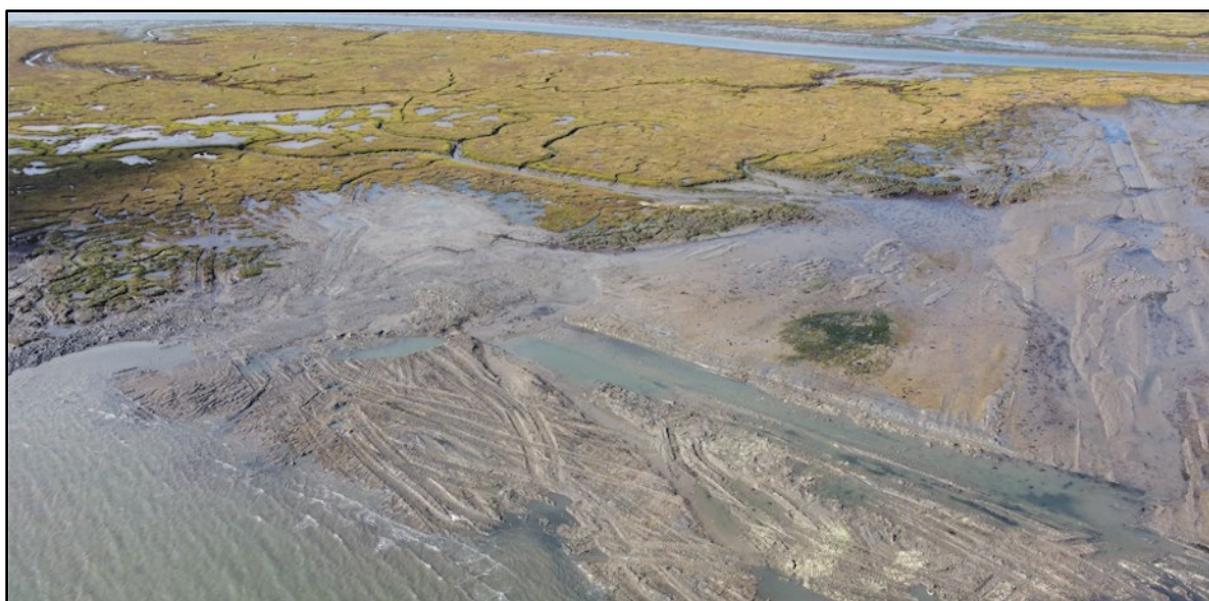
Image 10. Aerial view of Phase 2 area from south east after restoration

The outcomes of this campaign are illustrated in Figure 9 to Figure 11 and also in Image 10. Image 10 visually shows the working areas and clearly describes the areas of excavation and placement. These areas are also shown in Figure 9 which maps the net change in intertidal elevation (see also Figure 4 which makes the same comparison for the Phase 1 campaign). This figure was generated by comparing the bathymetry/topography surveys undertaken during 2025 before and after Phase 2.

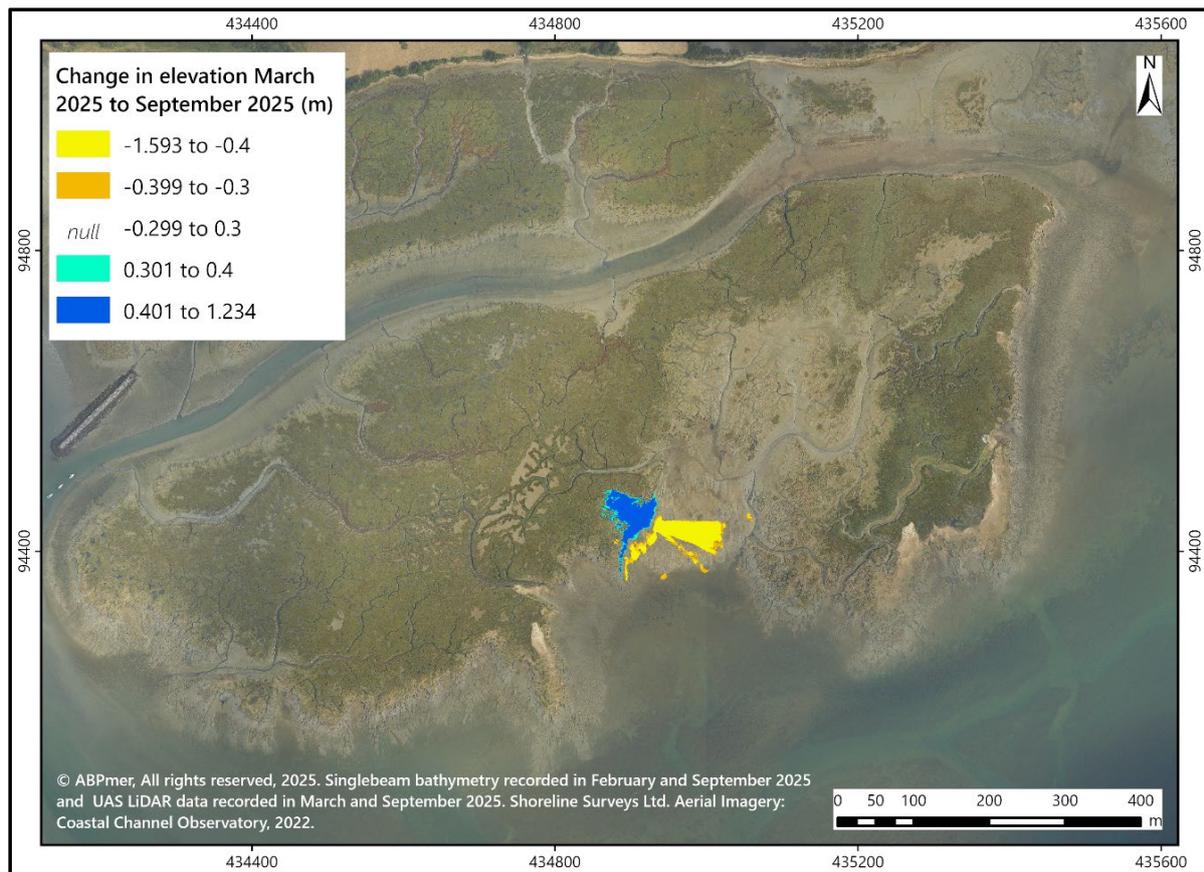
Figure 9. Changes in bed elevation between February and September 2025

The net result of the Phase 2 campaign was that around 3,000 m³ of sediment was excavated and moved. This value was derived by comparing the bathymetry/topography surveys undertaken during 2025 before and after Phase 2 (as illustrated by Figure 9). Using the same between-survey comparison, the volume placed on the deteriorating marshes for Phase 2 was calculated to be around 2,100 m³.

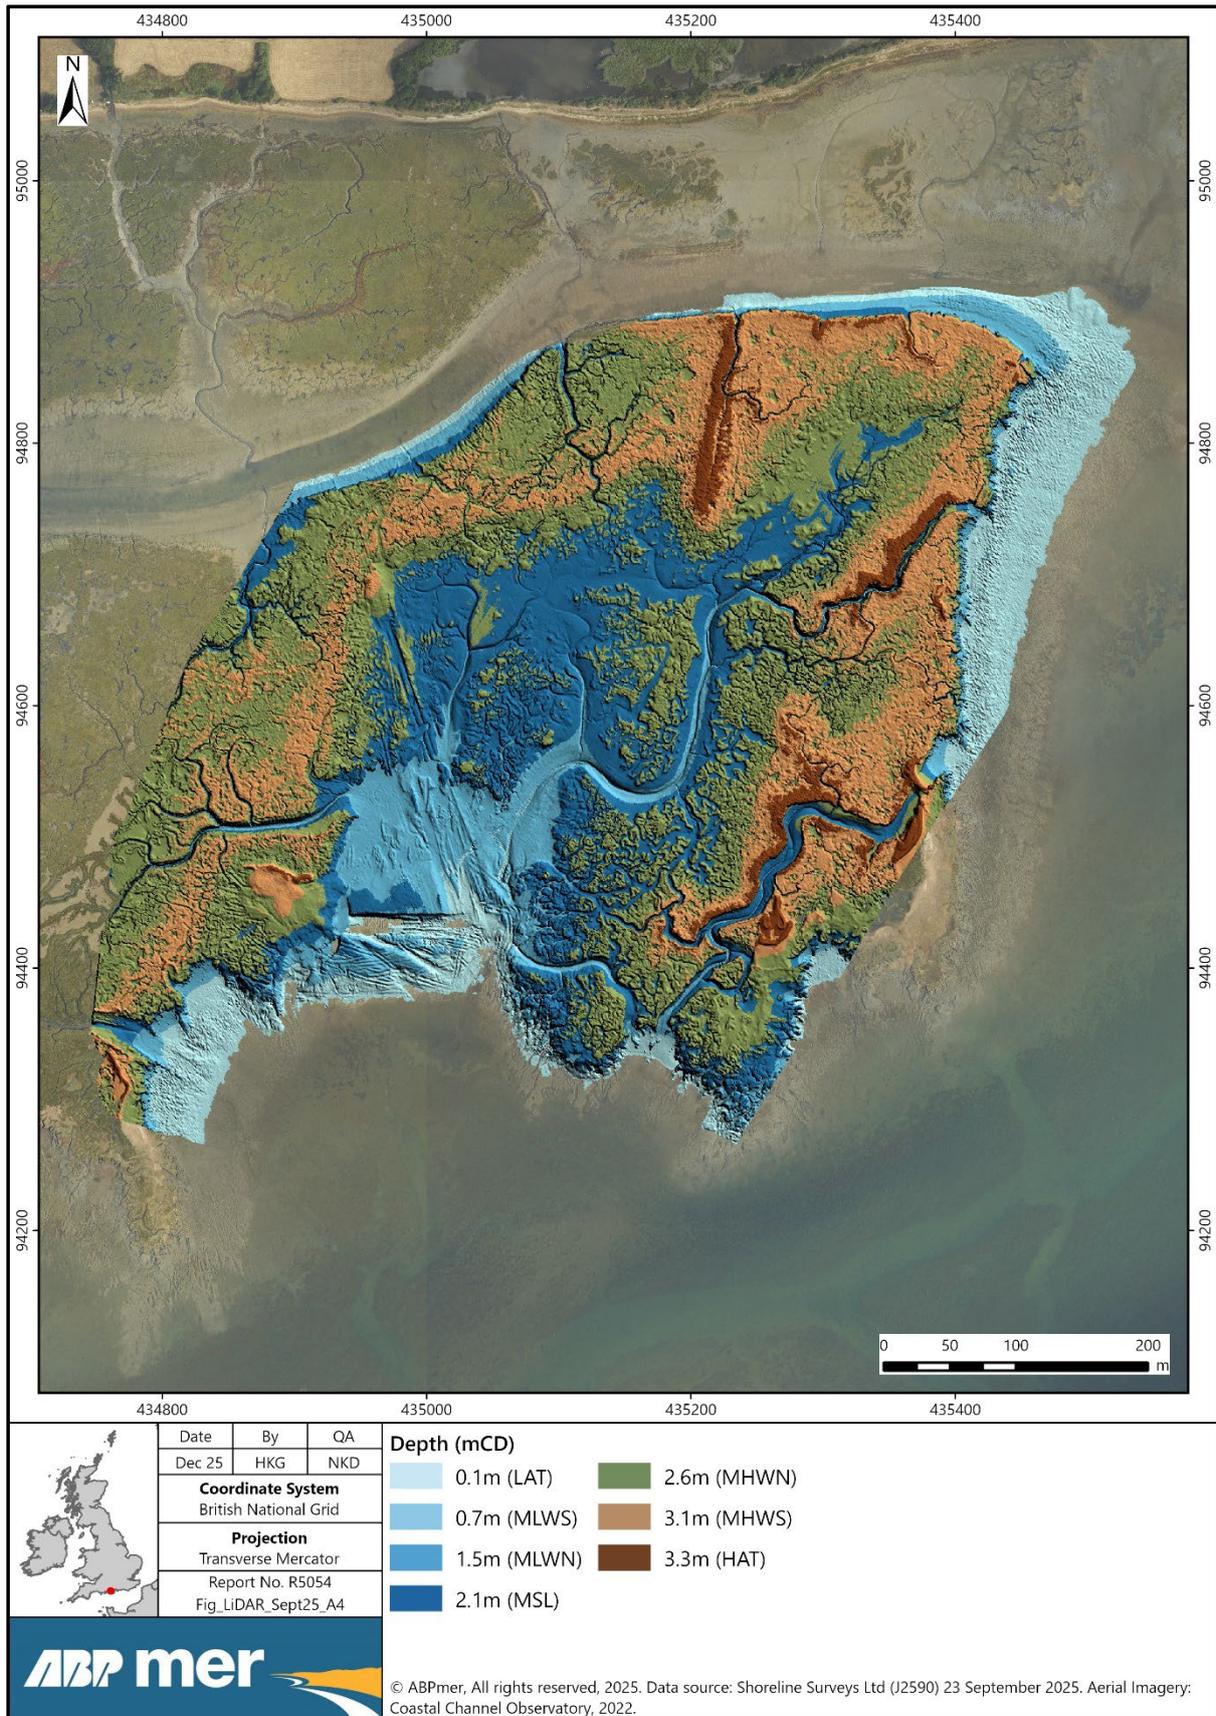
Figure 10. Bed elevations over eastern Boiler Marsh after Phase 2 (2025) trial

Figure 10 shows an enhanced topographic map of the site as produced by ABPmer using data collected by Shoreline Surveys Ltd on 22 September 2025. On this map it is possible to see the area of relocated sediment as well as the excavation zone and the drag box tracking marks for both the Phase 1 and Phase 2 campaign.

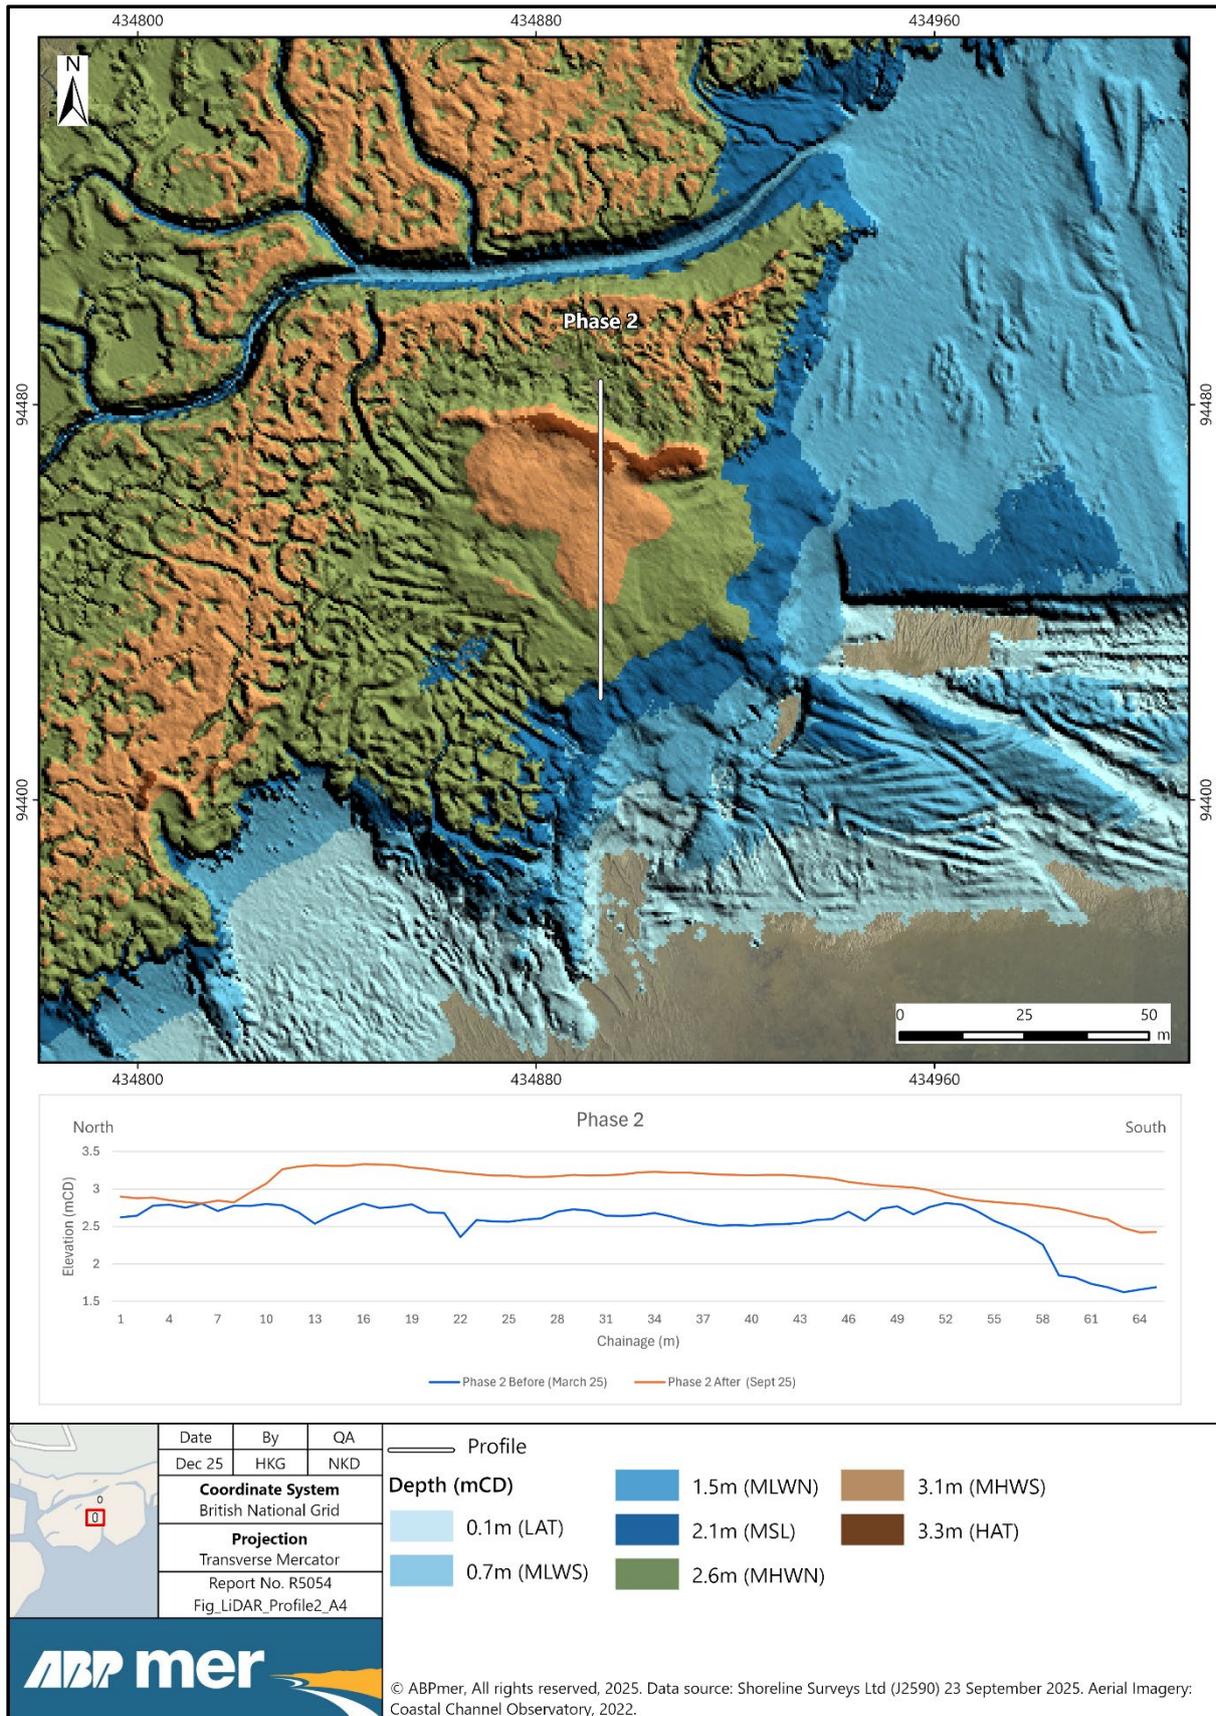
Figure 11. Bed elevation changes on the Phase 2 restoration area

Over the next year, a similar drop in elevation is likely to occur for the newly placed sediment at the Phase 2 site. If a similar settlement/compaction drop of 20 to 30 cm is experienced, that will lower the crest heights to around and just above the MHWS level.

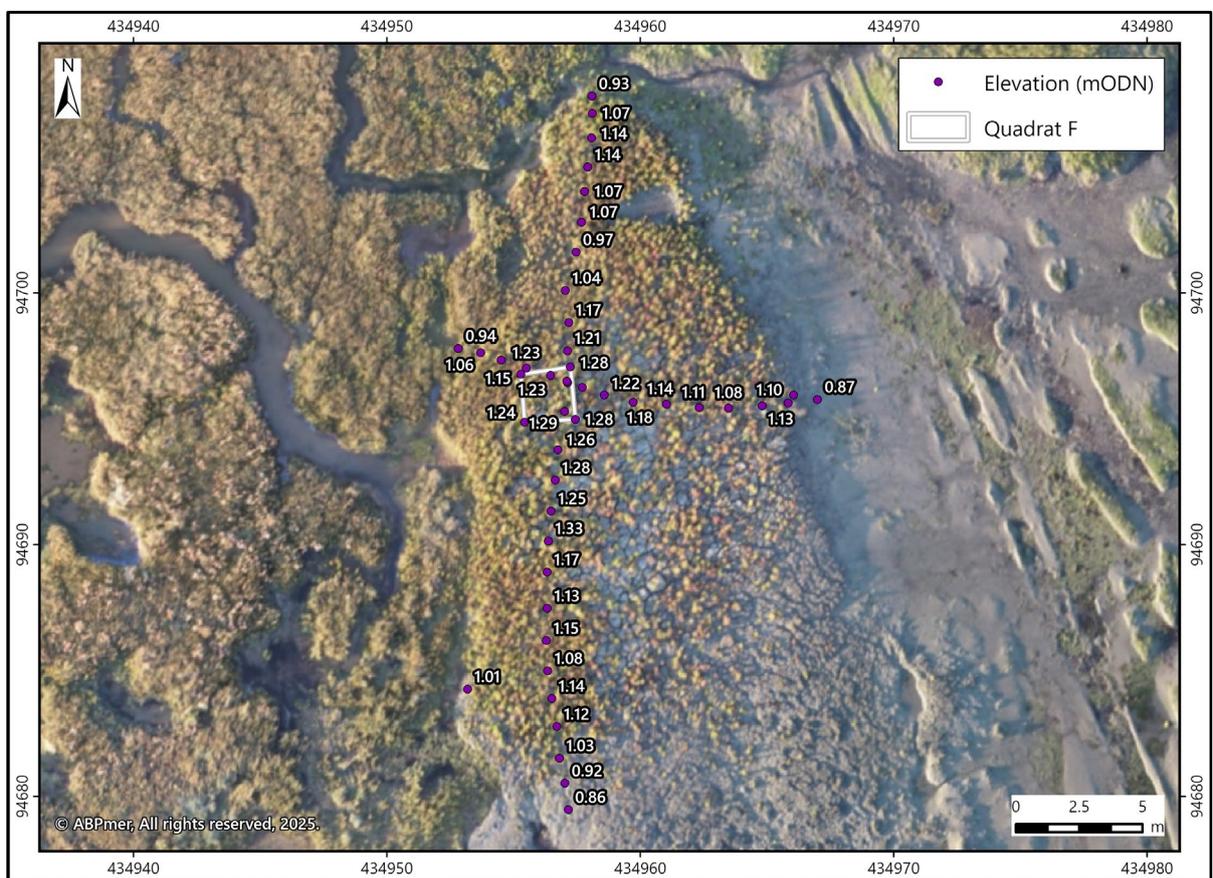
Figure 13. Plant cover and bed elevations across the Phase 1 area in 2025

The other main change was on the Phase 1 sediment mound. In the year since this was created there has been a relatively rapid colonisation of annual samphire and sea blite species. At the crest of the mound, where Site QF was positioned (which could be accessed for the first time during the September 2025 surveys) there was 60% cover of these species. This is shown in Image 8 and again in Image 13 which each show photographs of the QF quadrat. It is also illustrated in Figure 13 which shows the recorded bed elevation, and the QF quadrat location over the aerial image taken by Shoreline Surveys Ltd in September 2025. To further illustrate the change that took place over this mound in one year, Image 14 also shows what the sediment looked like (in its unvegetated condition) in October 2024 shortly after it had been placed.

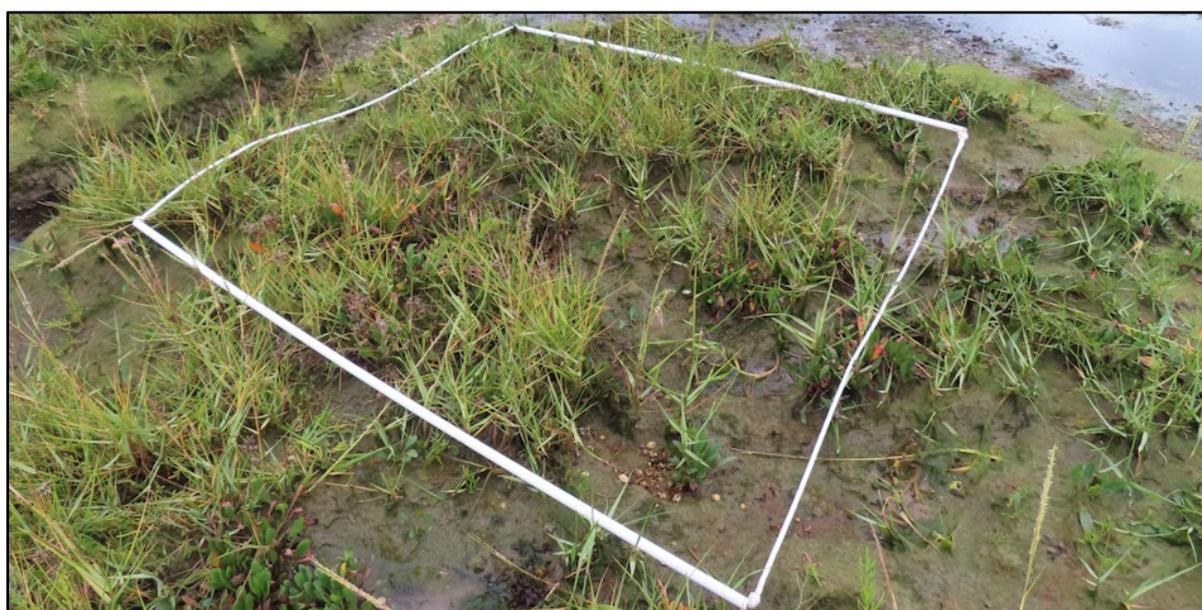
Image 11. Deteriorating internal marsh edge with mainly *Spartina* at Site Q2

Unlike the six locations described above, which were stable, there was an apparent change at Site Q2. This a relatively low-lying site (at 0.92 m ODN) but is also a wave exposed locations that has shown signs of deterioration and decline in plant cover over just the two years between 2022 to 2024. In 2025 there appeared to be even less vegetation cover at this site in 2025 than in 2024.

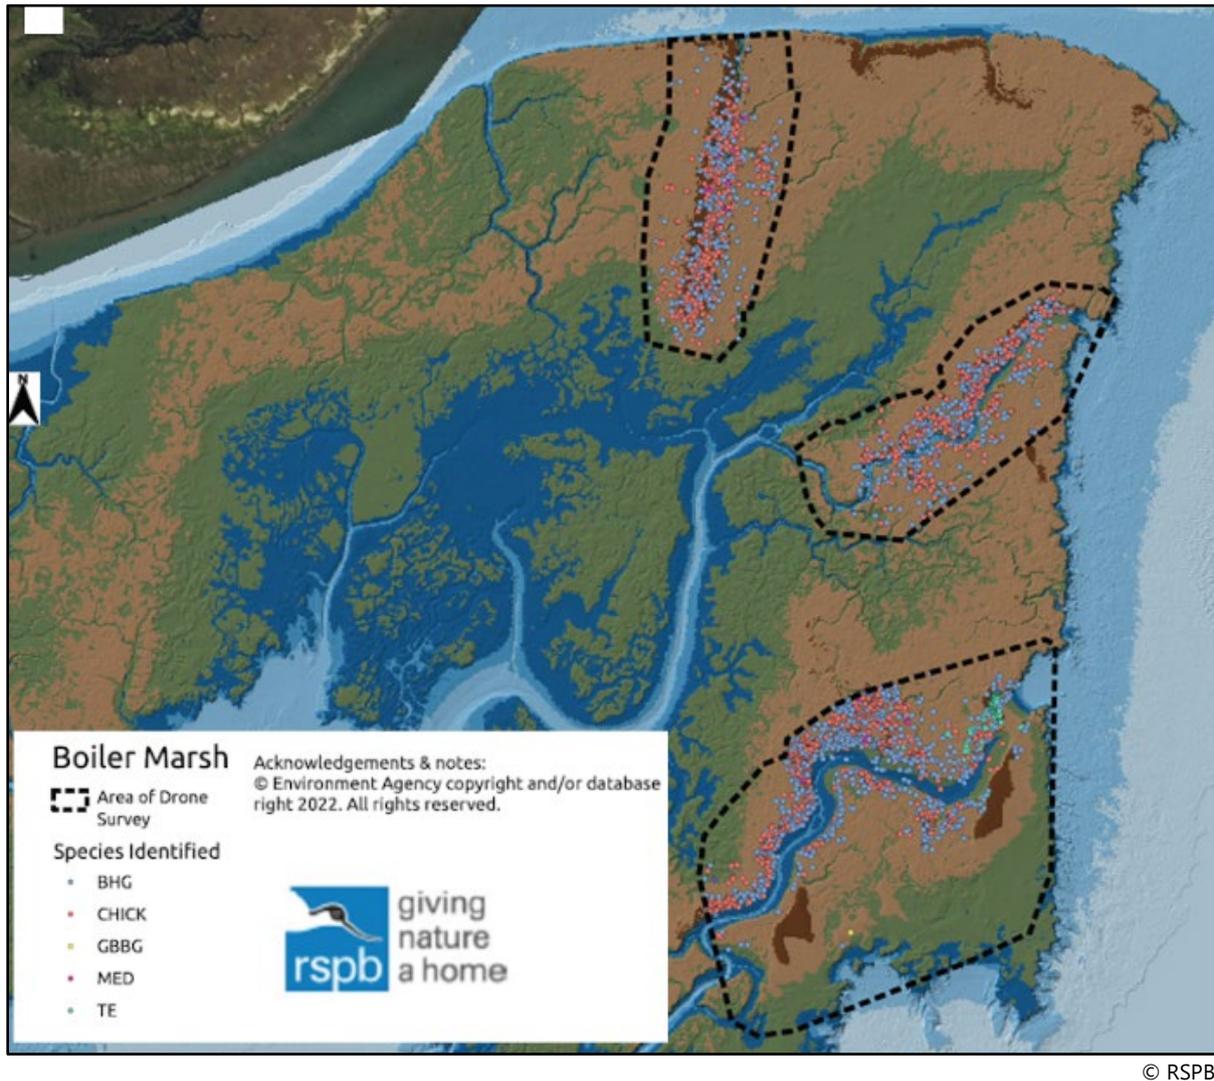
Image 15. Distribution of nesting seabirds recorded by 2024 drone survey

This image shows the areas where the drone surveys were carried out and the distribution of Black-headed Gulls (BHG), Great Black-backed Gulls (GBBG), Mediterranean Gulls (MED) and Terns (TE). As shown by the HCC monitoring work, these results illustrate how the main the nesting grounds are located on the higher lying parts of the eastern Boiler Marsh (these were the areas that were the focus of the drone survey).

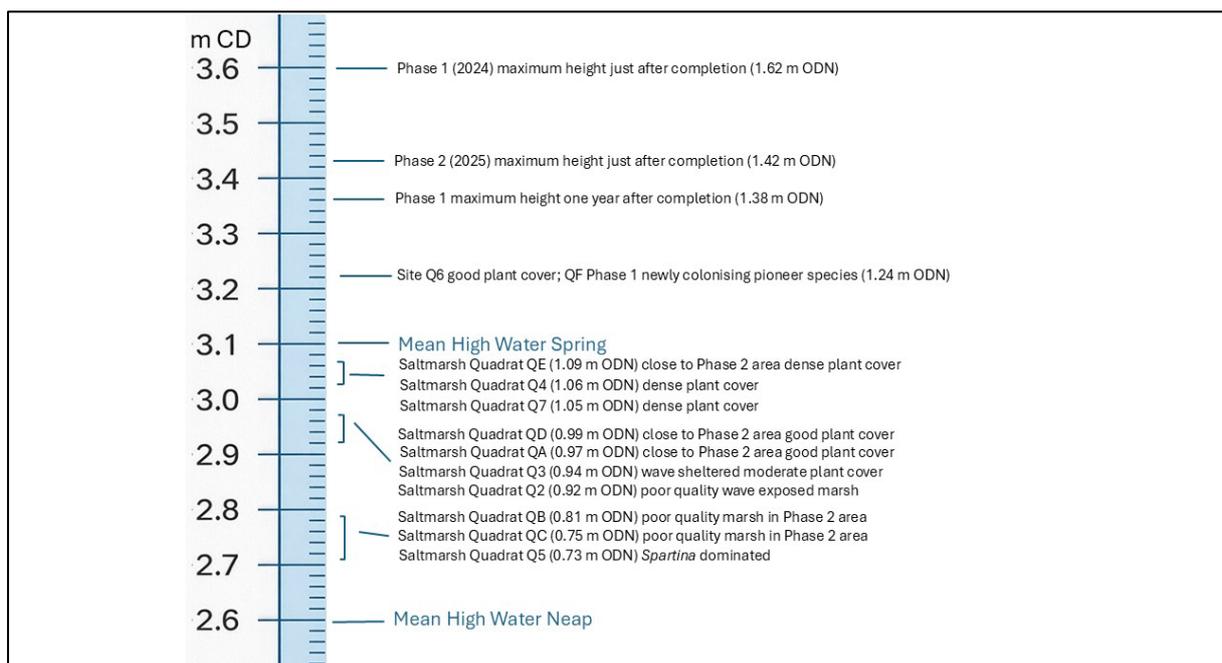
Image 16. Summary of intertidal elevations recorded on Boiler Marsh in 2024 and 2025

On Boiler Marsh vegetation occurs at elevations above 0.73 m ODN (depending on the level of wave exposure) with bird nesting occurring on areas of dense plant growth at higher elevations above MHWS (see Image 16) closer to 1.24 m ODN. The key reason for the differences is the duration of tidal inundation. Habitats at the lower end of this range are inundated around 22% of the time annually while areas at the upper end are covered 0.04% of the time (based only on annual predicted tides and not taking account of storms and surges).
