Beneficial Use of Dredged Sediment to Improve Boiler Marsh, Lymington (Year 2)

Review of restoration activities and monitoring undertaken for the second trial campaign in 2025

January 2026

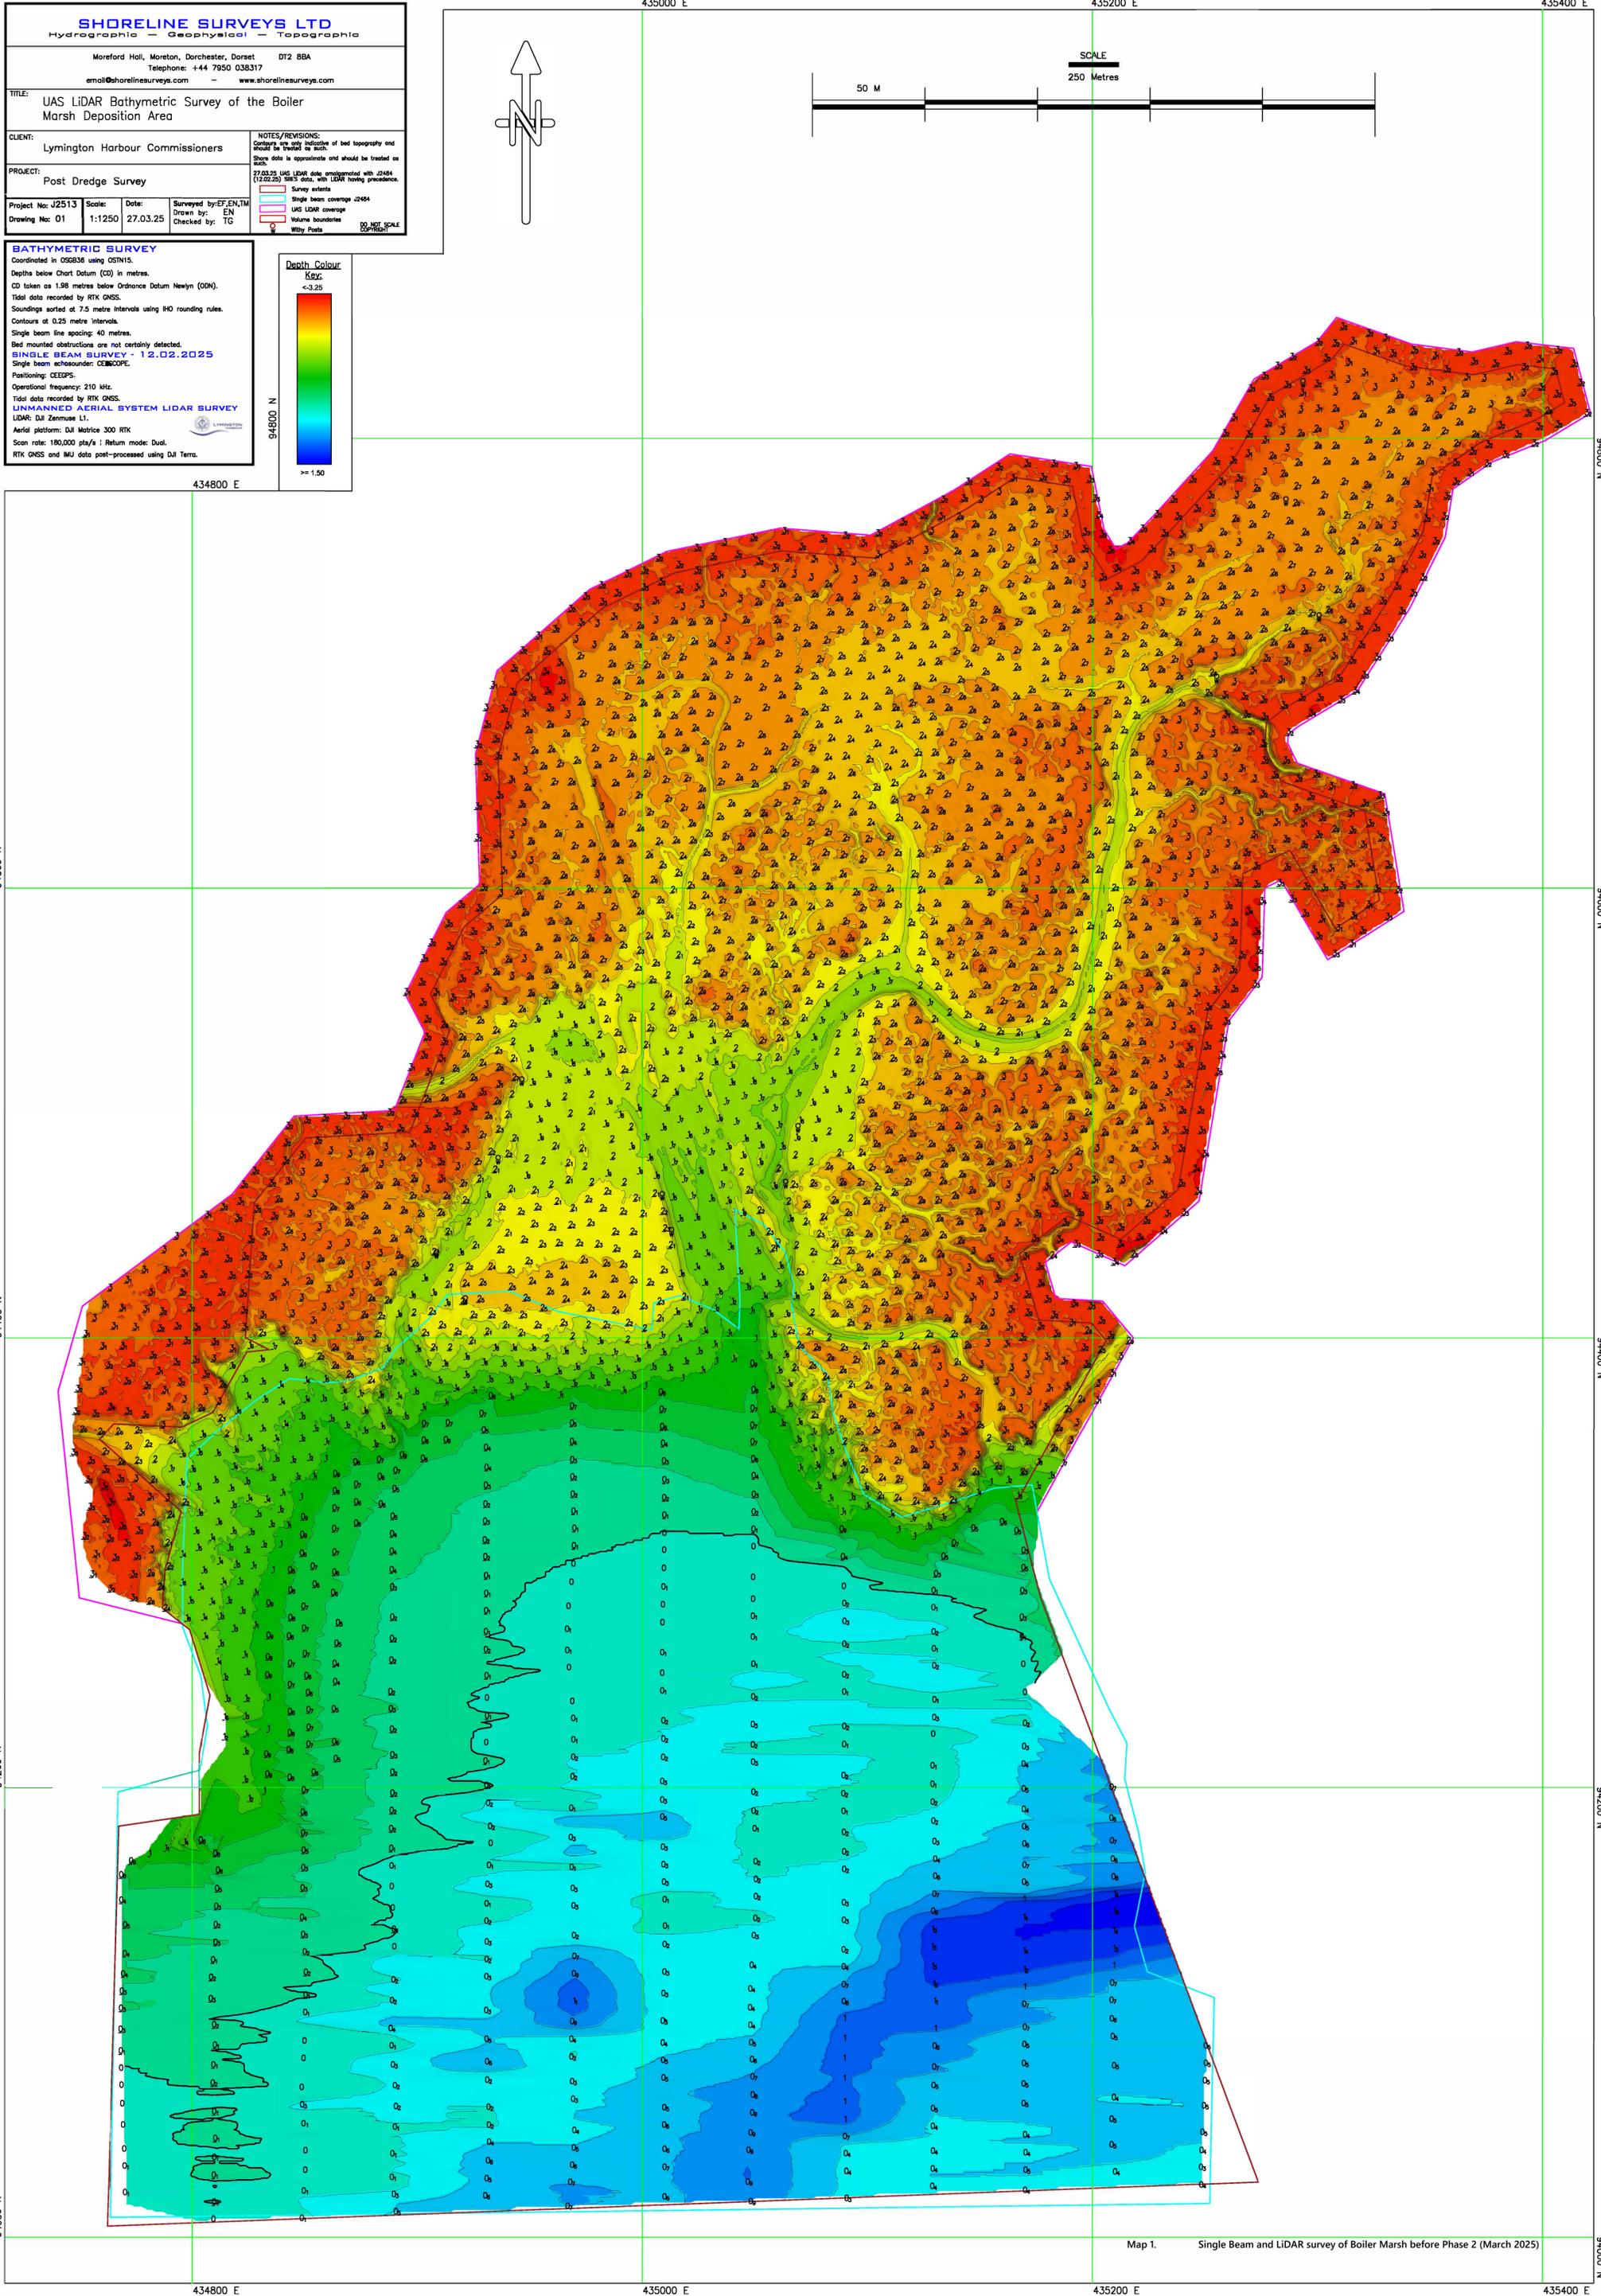
Map 1. Single Beam and LiDAR survey of Boiler Marsh before Phase 2 (March 2025)

BATHYMETRIC SURVEY
 Coordinated in OSGB36 using OSTN15.
 Depths below Chart Datum (CD) in metres.
 CD taken as 1.98 metres below Ordnance Datum Newlyn (ODN).
 Tidal data recorded by RTK GNSS.
 Soundings sorted at 7.5 metre intervals using IHO rounding rules.
 Contours at 0.25 metre intervals.
 Single beam line spacing: 40 metres.
 Bed mounted obstructions are not certainly detected.
SINGLE BEAM SURVEY - 12.02.2025
 Single beam echosounder: CEMCOPE.
 Positioning: CEEGPS.
 Operational frequency: 210 KHz.
 Tidal data recorded by RTK GNSS.
UNMANNED AERIAL SYSTEM LIDAR SURVEY
 LiDAR: DJI Zenmuse L1.
 Aerial platform: DJI Matrice 300 RTK
 Scan rate: 180,000 pts/s | Return mode: Dual.
 RTK GNSS and IMU data post-processed using DJI Terra.
