# Wallasea (North) Managed Realignment Scheme (England)

*Case Study*

March 2011

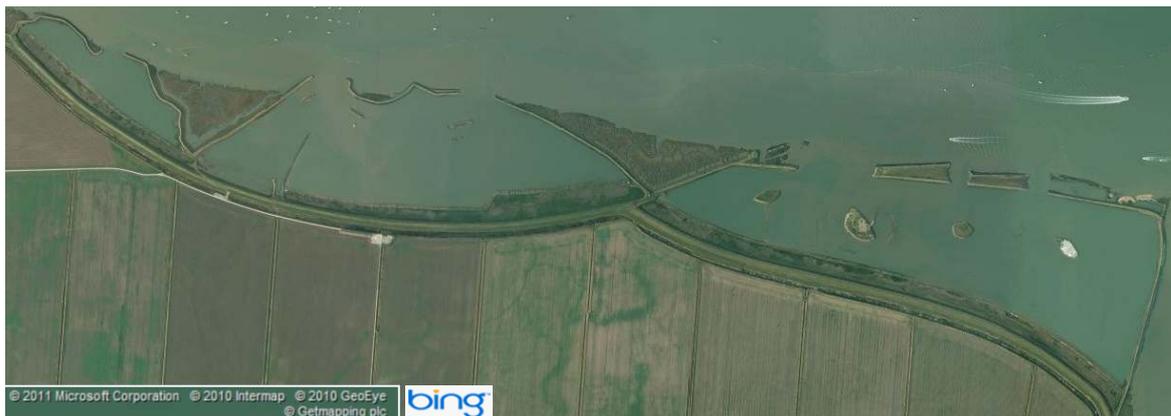
**Plate 1.** The managed realignment along the north bank of Wallasea Island (at high tide) – Bing Maps derived aerial view

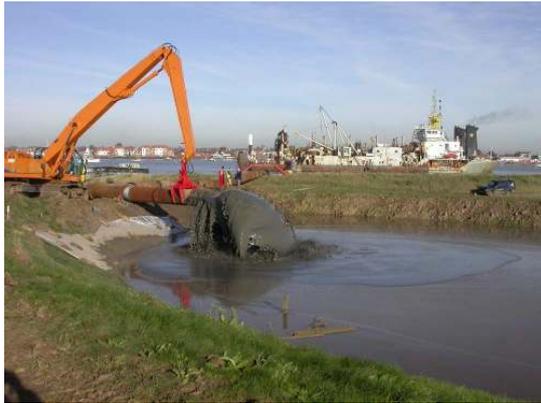
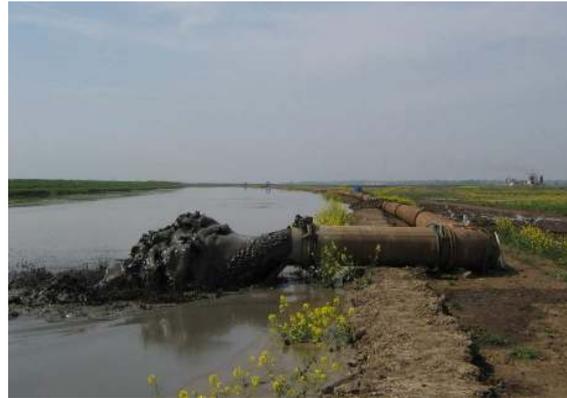
### Plates 2 & 3. Dredge sediment recharging in November 2005 and May 2006

For this scheme a new secondary wall was constructed (in 2005) about 400m back from existing sea defences. This new wall was an extension to one that had been constructed three years previously by the landowner. The majority of the site fronting these walls was at an elevation half way between Mean Low Water (MLW) and Mean High Water Neap (MHWN) and thus was suitable for mudflat development. To also create an area of saltmarsh, 550,000m<sup>3</sup> of maintenance dredge arisings (from the Port of Harwich) were placed on the seaward side of the walls. This was deposited in a 45m-wide strip – it was contained by the new sea wall and a clay bund to its seaward side. The topography was raised to a level just below the Mean High Water Springs (MHWS) level using this sediment recharge approach. In addition, within the site, seven island features were created. A new borrow dyke (soke dyke) was excavated on the landward side of the new counterwall. No new internal creeks needed excavated to promote effective site filling and draining on each tide because the existing field drains and borrow dyke on the site fulfilled the function very effectively without manipulation. One new channel did have to be introduced though to connect one of the breaches directly back to a flood management sluice in the new sea wall.

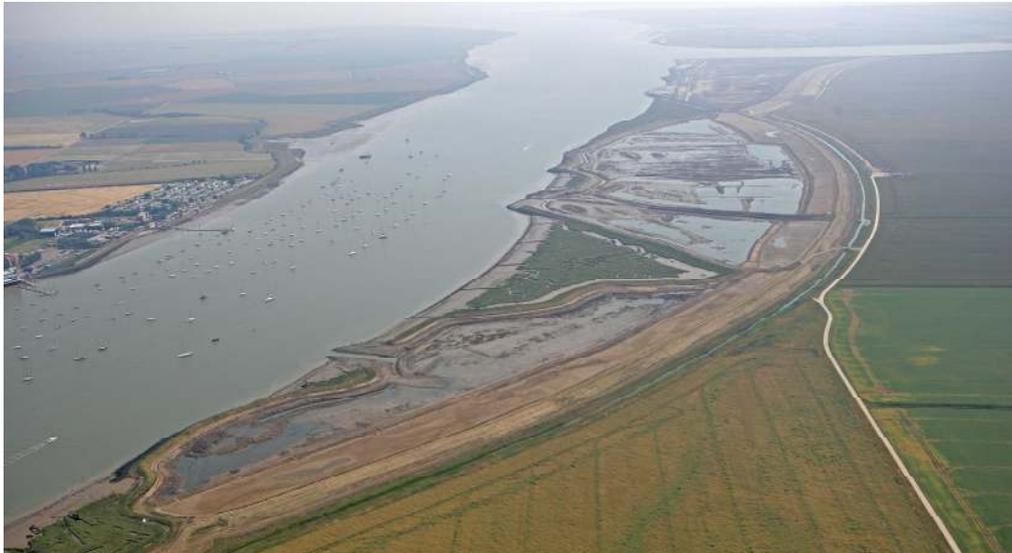
**Plate 5. The site on the final day of breaching (view east)**

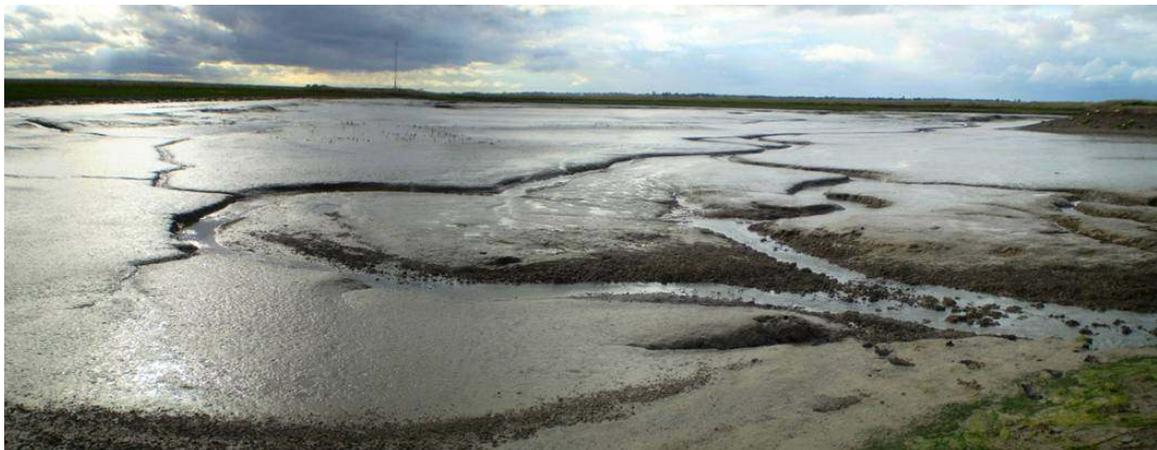
### **Plate 6. View of mudflat within site, showing drainage creeks formed as sediment has accreted**

Within the site, sediment accretion has occurred relatively consistently and evenly due to the slow flows and stable internal creek/channel configurations. In the first year after breaching (2006 to 2007), accretion was around 10cm (of which about 50% is considered internally relocated materials and 50% externally imported sediments). In each subsequent year, the annual accretion is considered to be predominantly related to imported sediments and amounted to 3 to 5cm on average (specifically 5cm in both 2008 and 2009, and 3cm in 2010).

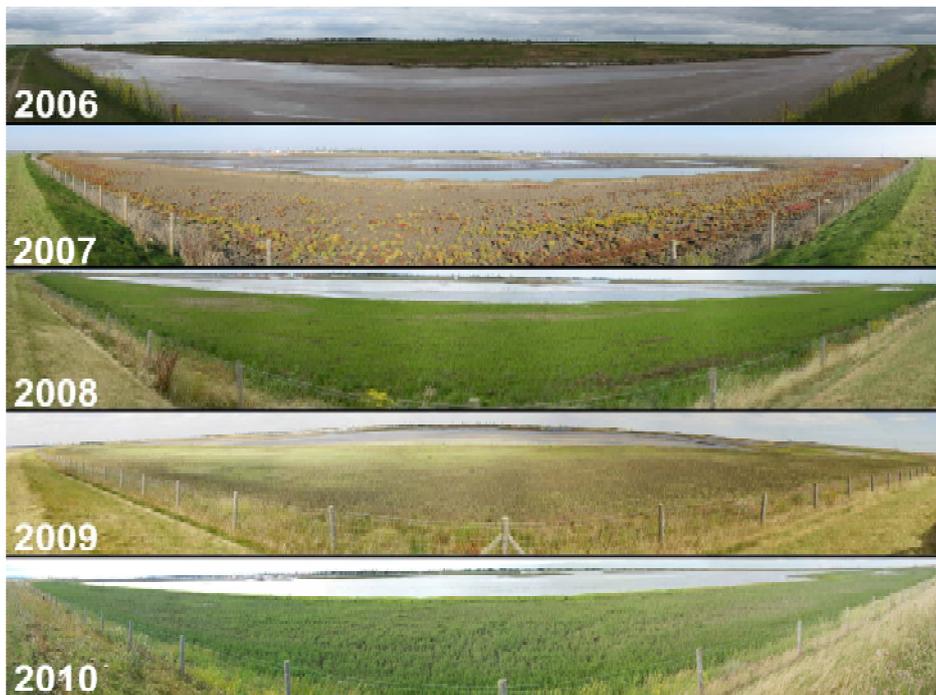
**Plate 7. Fixed-point photographs showing the rate of saltmarsh development on the recharge sediment**

Saltmarsh coverage of elevated areas of the sites (approx 25ha in extent) has occurred relatively rapidly. On average plant coverage (i.e the amount of marsh plant compared to bare mud at any given location) has rapidly increased from less than 1% in 2007 to 6% in 2008, 60% in 2009 and finally at or around 100% in 2010.
