# Horsey Island Coastal Restoration - 10 Years On

Review of UK's first and largest mixed-sediment  
beneficial use projects

ABPmer Internal White Paper  
March 2016

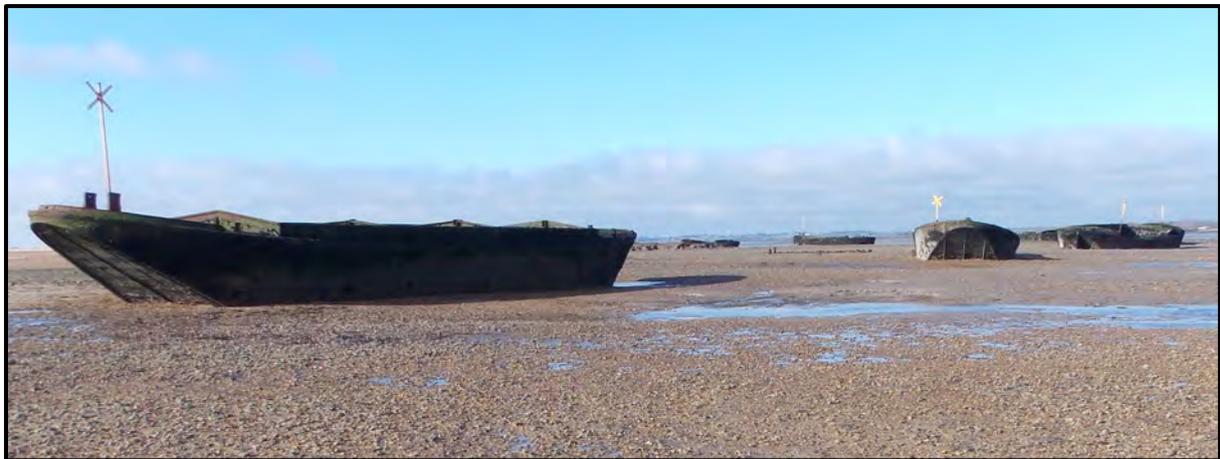
Image 2. Six of the Thames lighter barges at Horsey Island

Today, one of the most visually distinctive features of the north-eastern shoreline of Horsey Island is the alignment of 18 Thames Lighter Barges along the foreshore (see Images 2, 3 and 4 and Figure 1). In the first phase of work at this site, these were placed here in 1988 at a cost of around £40,000 and were designed to break up a large proportion of the wave energies across the shoreline behind.

These barges were aligned in a shore-parallel direction and filled with mud after they were sunk into position. They were evenly spaced and set at an elevation which ensured that they remained proud of the water surface on spring tides. The wave energy effects of this alignment were modelled and considered to remove 70% of wave energy.

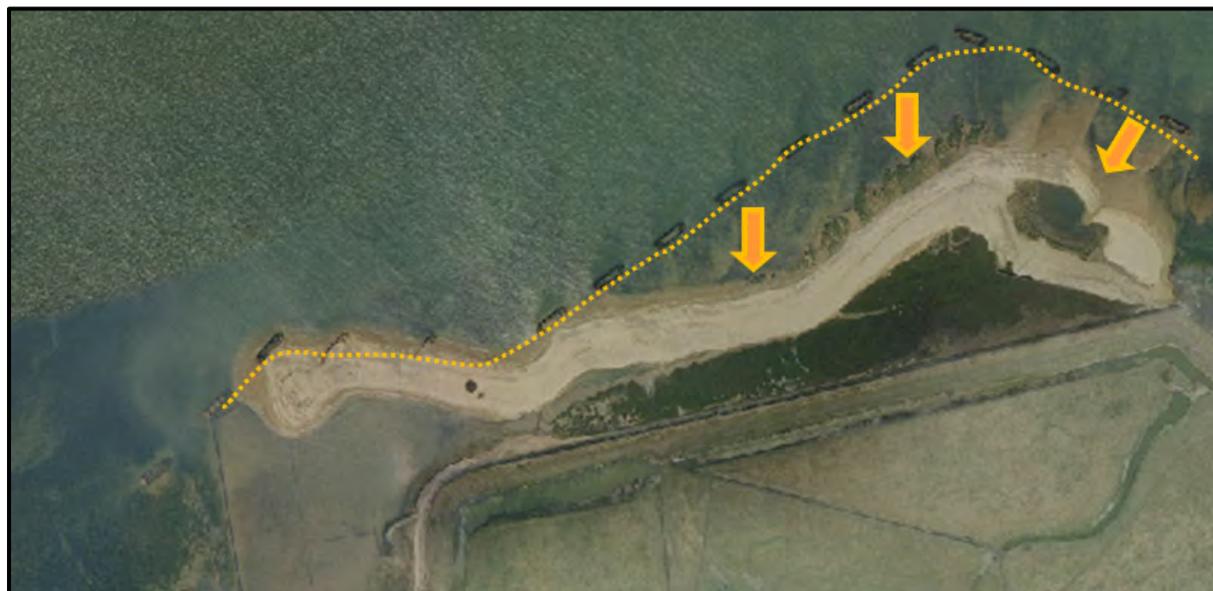
**Image 4.** Migration of sand/shingle recharge from deposition during early 1990s to 2000 (date of aerial image)

and consenting elements were being progressed), the barrier migrated landward. The direction and pattern of movement is illustrated in Image 4.

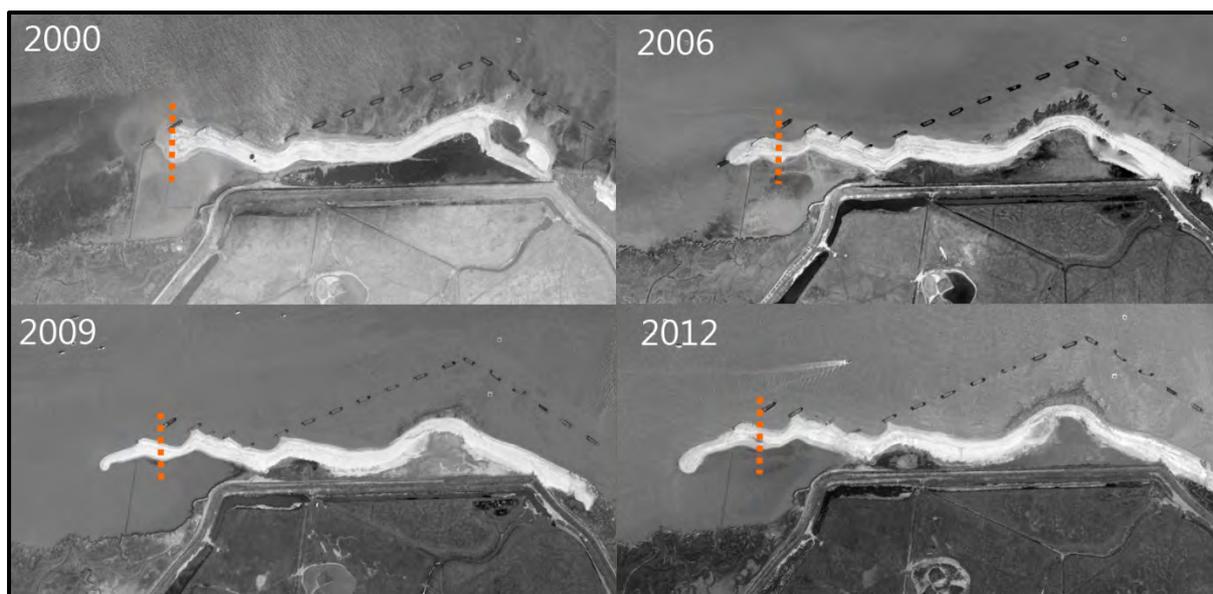
**Image 5.** Behaviour of the shingle barrier from 2000 to 2012 showing greater stability than preceding decade

In 1998, 2001 and 2003, the silt recharges behind the barrier were undertaken (Phases 4 and 5) as described further in Section 2.5. After these recharges the shingle barrier evidently became much more stable. Image 5 includes aerial views that describe the alignment of shingle in 2000, 2006, 2009 and 2012. Over this period the main changes have involved a westerly extension of the barrier while some wind-blown sand has also migrated landward (southerly) over the surface of the recharged marsh habitat (IECS, 2011).

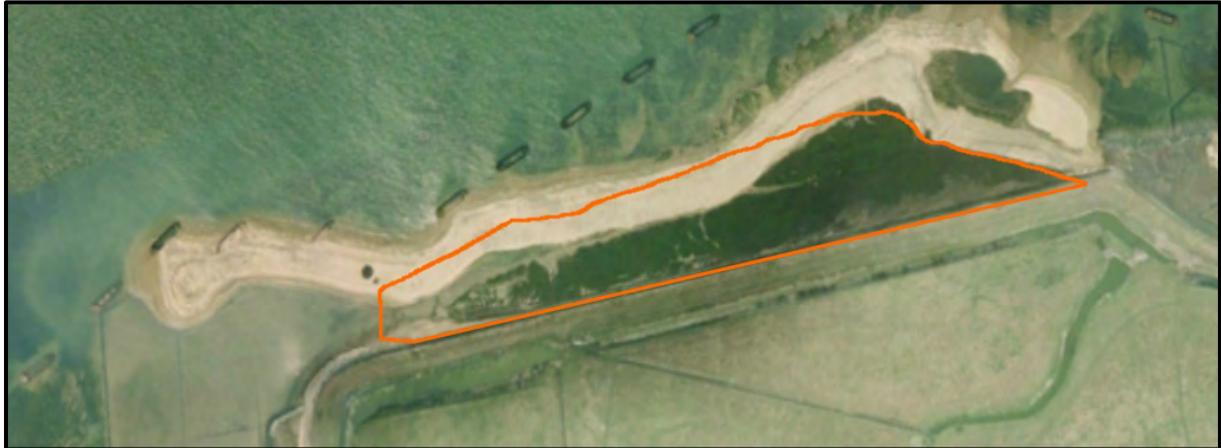
**Image 6.** Location of the 1998 silt recharge (indicated over aerial photograph from 2000)

In February 1998 silts, again from the Port of Harwich, were discharged between the new sand/shingle barrier and the sea wall. To contain the material at the eastern and western flanks of the placement area, respectively, a brushwood fence and a line of sand bags were put in place prior to the work. These defined an area of around 2.7 ha (see Image 6). For this project around 20,000 m<sup>3</sup> of dredged fine muddy sediment was pumped ashore through a 450 mm diameter temporary steel pipeline laid from a trailing suction dredger.

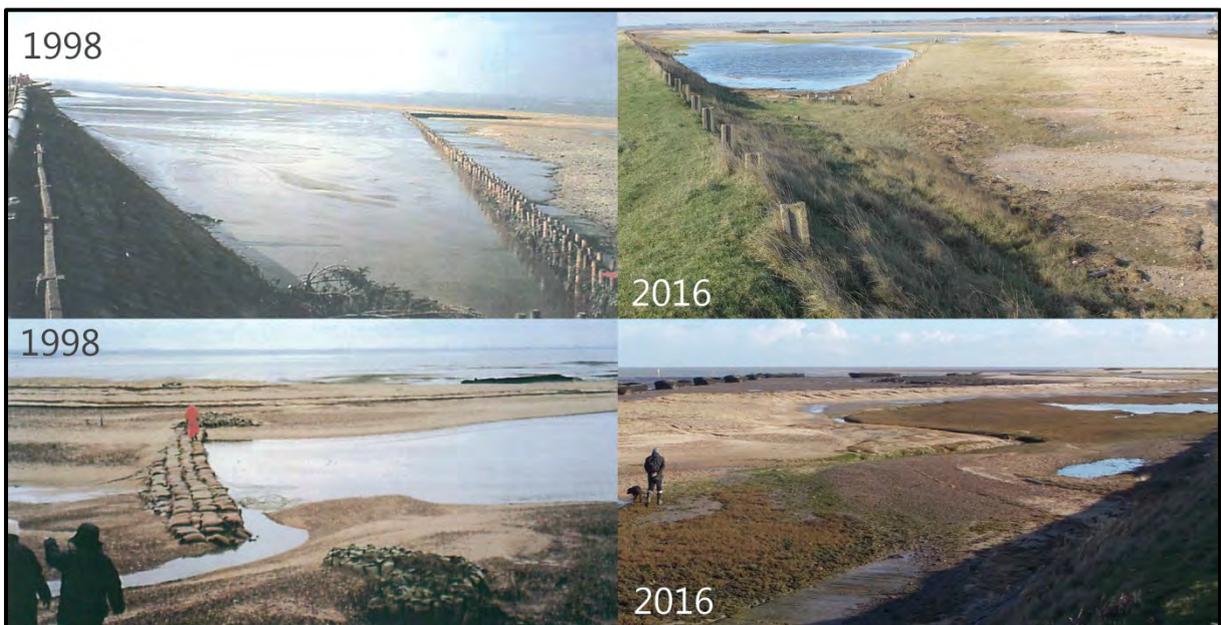
**Image 7.** Views of eastern (top) and western (bottom) parts of the large-scale silt recharge area

On release, the recharge sediment emerged at quite a thick consistency and initially settled close to the discharge point before gradually ‘winnowing out’ more evenly across the site. However, even on completion the surface of the deposited sediment exhibited a sloping gradient extending to the east away from the discharge points. Overall, the project raised the bed levels by up to 1 m (and typically between by 0.5 m to 0.75 m), with limited apparent loss through the brushwood fencing (see Image 7).

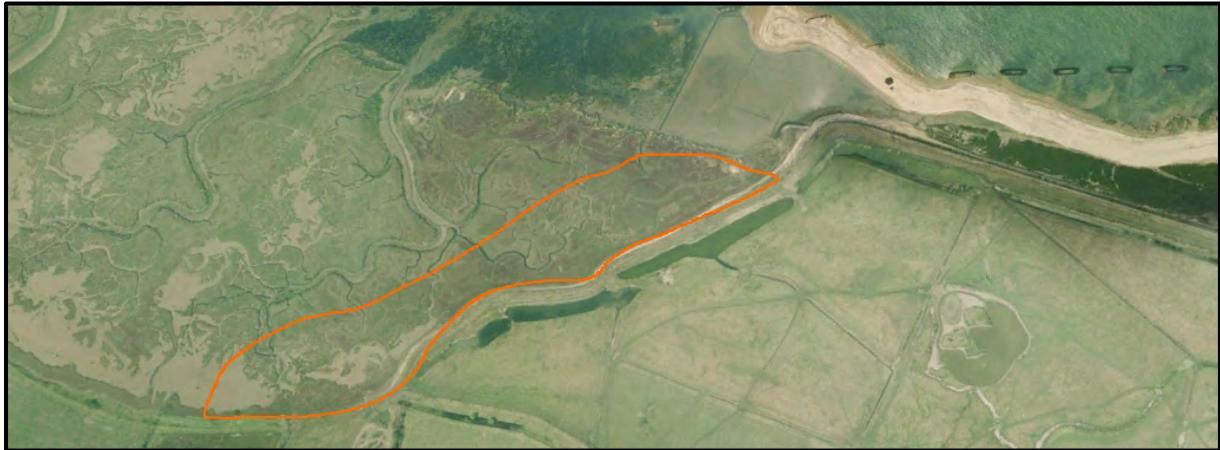
**Image 8.** Location of the 2005/06 silt recharge (indicated over aerial photograph from 2000)

In total around 47,000 m<sup>3</sup> was imported over two stages; firstly, in November 2005 (21,000 m<sup>3</sup>) and then in January 2006 (26,000 m<sup>3</sup>). The recharged area was around 0.5-1 ha in size and is illustrated in Image 8.

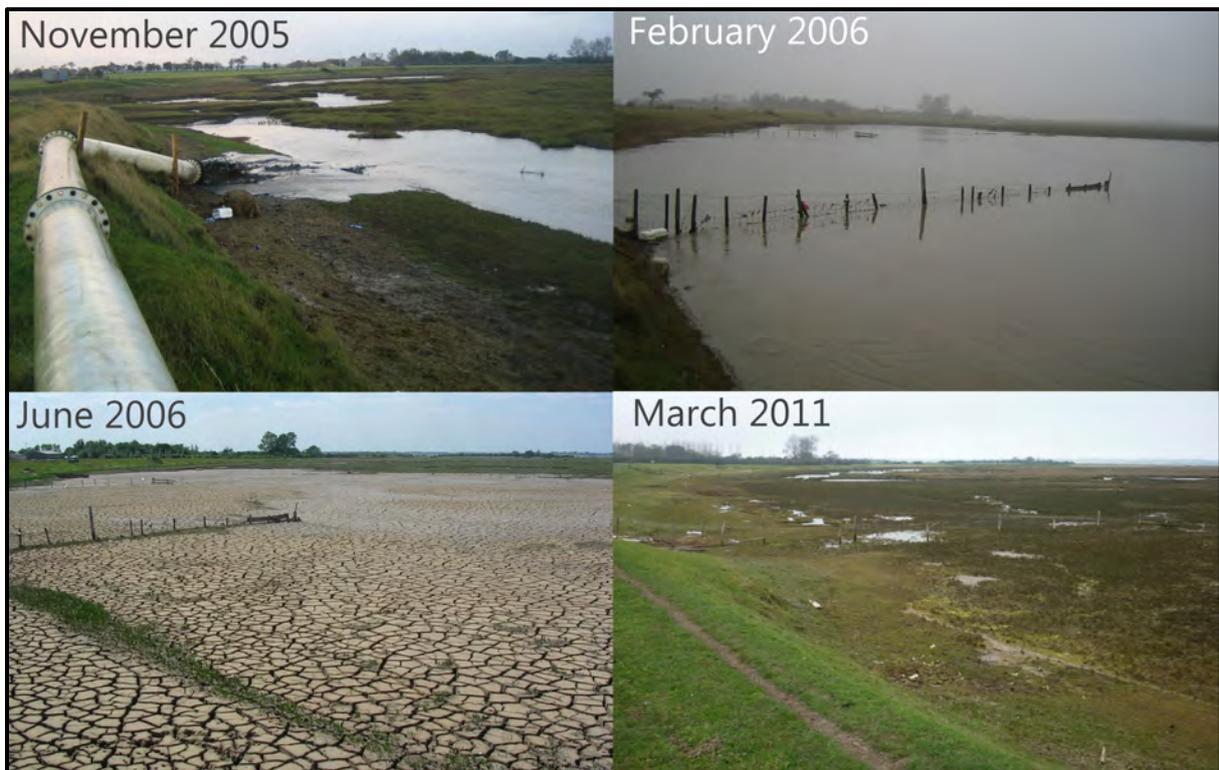
**Image 9. Views of Phase 6 silt recharge from 2005 to 2011 (top of the shoreline)**

In the decade since this work was completed, it is evident that the material which settled during the recharge has largely remained in place. There is no clear sign of significant sediment export or erosion. In the first instance this is indicated by visual observations on-site (see Images 9 and 10), but it is also confirmed by analysis of aerial imagery and remote sensing data. For example, Image 11 shows aerial views that describe the area before and after the recharge. They show that the recharged area remains visibly distinct over the period from 2005 to 2012. It is also evident that there was a clear area of marsh growth over former mudflat/saltpan habitat on the southern-most section of the recharge area. More recent surveys of this saltmarsh enhancement/recreation area over the 2012/13 winter have concluded that the area has developed well, with good saltmarsh plant cover (CJT Ecology 2013).

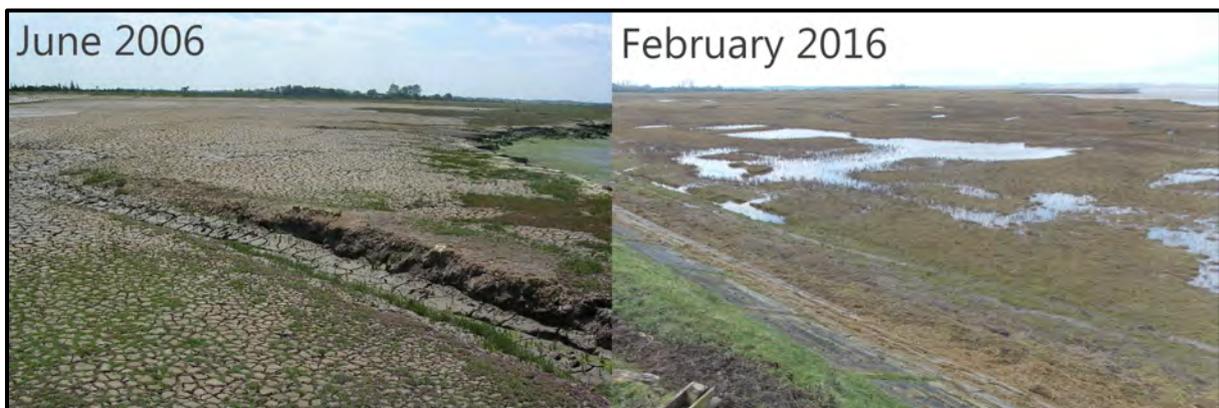
**Image 10. Views of the Phase 6 silt recharge in 2006 and 2016 (seaward marsh edge)**

On-site evidence also indicates that the mudflat in front of the recharge and behind the prograded shingle spit features has remained stable and even accreted both in front of and behind a polder fence which runs across the shoreline. This change is likely to be the result of to a combination of factors, including: the release of sediment from all previous recharges, the sheltering effect of the extended shingle barrier and the reduced volumes of tidal water exchange across this part of the foreshore following the recharge works.

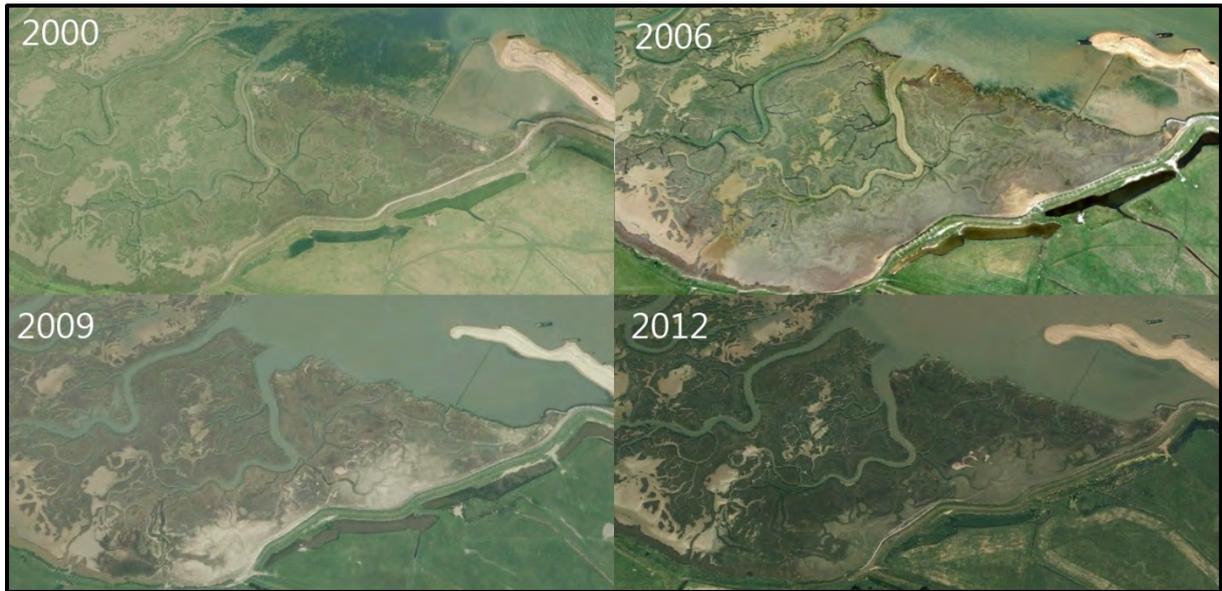
**Image 11.** Saltmarsh recharge area before and after the 2005/06 recharge

The recharge silt buried the marsh and the creek system under a layer of surface mud. The depths of deposition varied depending upon the underlying topography but was approximately around 30 cm to 1 m over the marsh surface but at greater depths (up to around 1.5 m) over the lower elevation creeks and pans. Images 9 and 10 describe the conditions on the site (from approximately comparable locations) both during and after the recharge. Post implementation monitoring showed new saltmarsh plant growth began within three months and that large amounts of sediment were retained *in situ*. This element of the project has been identified as one of the most successful schemes of its type in creating intertidal habitat and reducing flood maintenance costs (ComCoast, 2007).

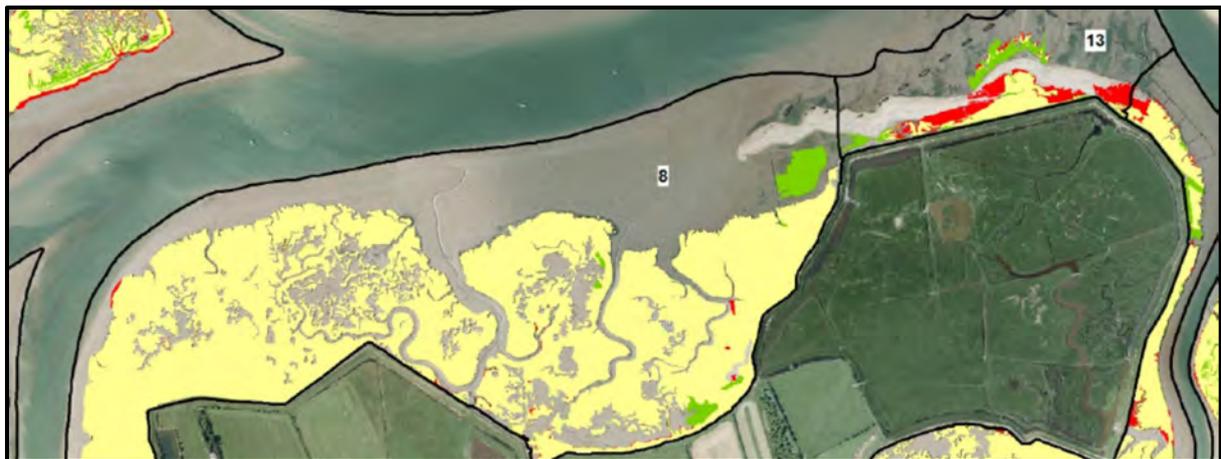
**Image 12.** Approximate changes in saltmarsh extent 1997 to 2008 (green areas in SSSI Unit 8 show marsh gain or raised mudflat)<sup>10</sup>

Prior to considering this LiDAR data, however, it is firstly noted that the general persistence of the sediment used in the silt recharge has previously been indicated by a comparison of aerial images from 1997 to 2008 (IECS, 2011). This work was undertaken as a part of a much broader review of marsh extents throughout Essex and Suffolk but it did show an expansion of the marsh to the south and of the mudflat to the north of the 2005/-06 recharge area. This is illustrated as green patches (seen within SSSI unit 8) on Image 12.

<sup>10</sup> Within SSSI Unit 15 the area coloured red indicates sand migrating over the marsh surface (as described in Section 2.2).

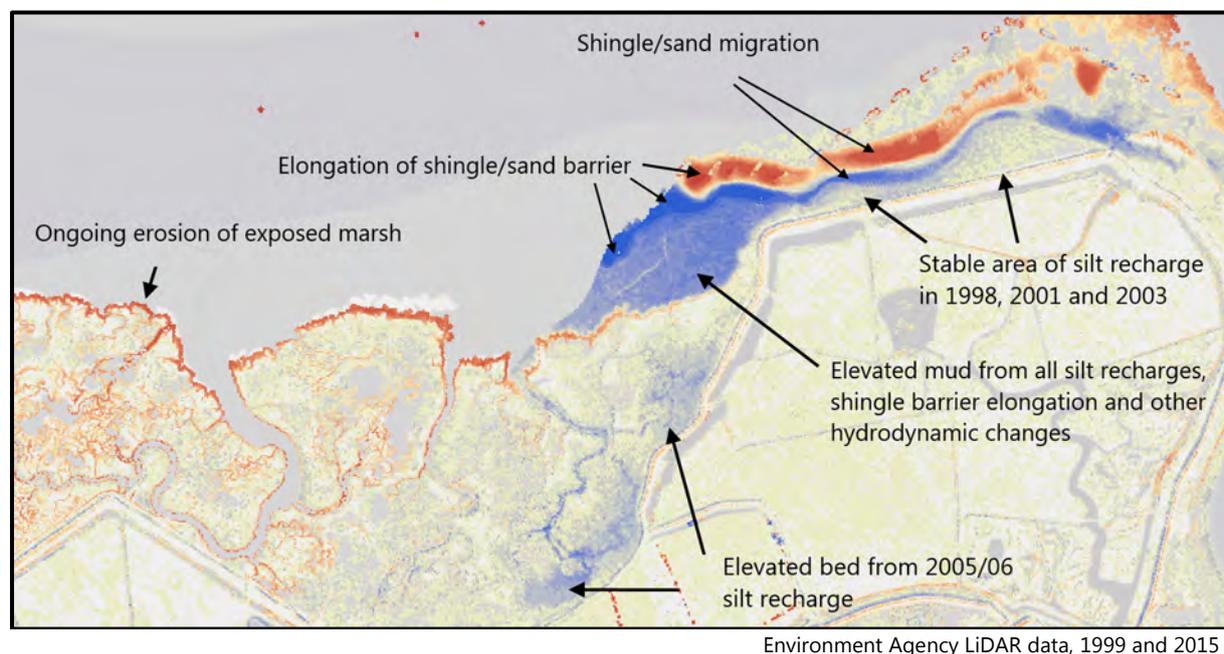
**Image 13.** Difference in elevation between the 1999 and 2015<sup>11</sup>

interpreting long-term trends with just one or two surveys). However, Figure 2 does show how (and where) the silt recharge material has been retained. These areas are further illustrated and annotated in Image 13. In addition to showing the silt retention, this image (and the larger Figure 2) also highlights areas where the sand/shingle has migrated and extended.

An examination of the LiDAR data over the main intertidal areas that were affected by the Phase 5 and 6 silt recharges indicates that there is 64,000 m<sup>3</sup> more silt present in 2015 than there was in 1999. This volume represents around 73% of the full Phase 5 and 6 recharge volumes. When it is borne in mind that there will have been post-recharge settlement and compaction of the deposited material, this value on its own indicates that the majority of the sediment has been retained (or at least that there has not been a substantial net export of sediment from the site).

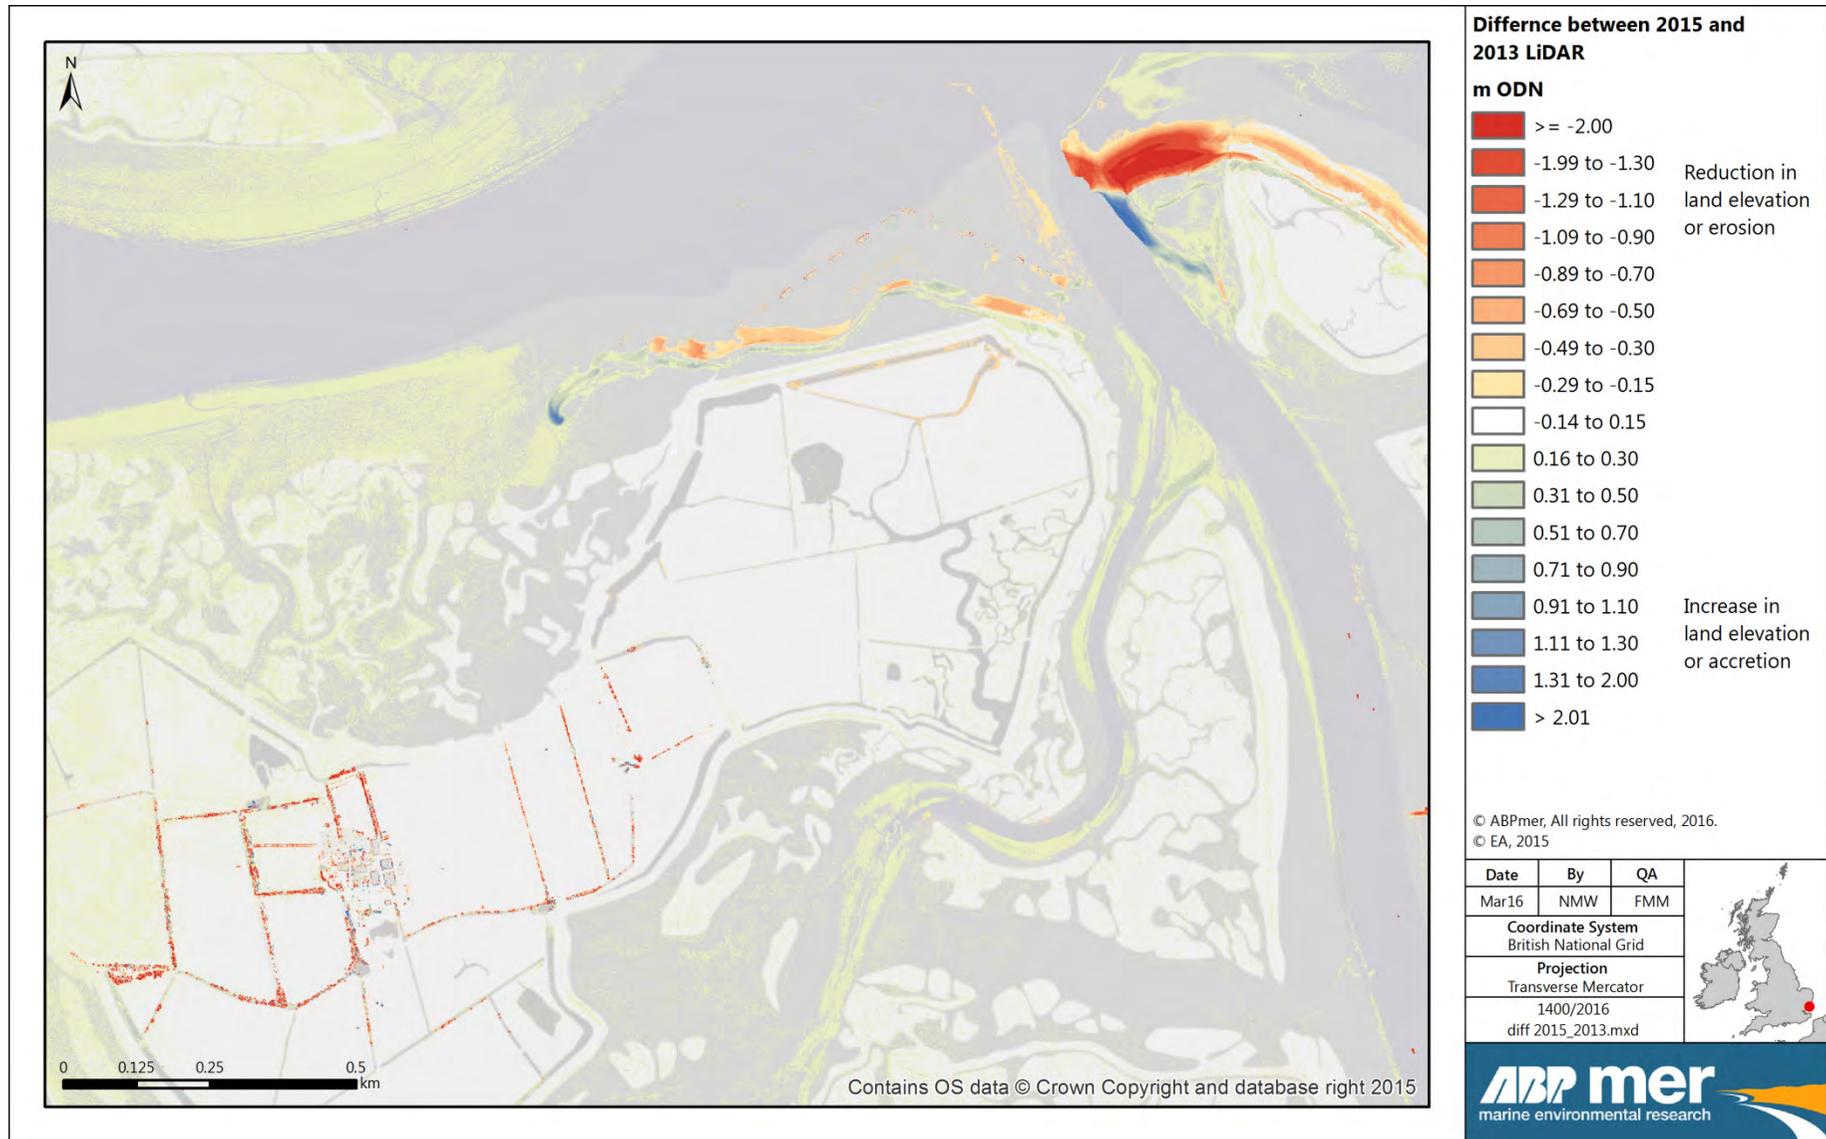
Figure 3. Difference in elevation between the 2013 and 2015 LiDAR datasets

Figure 3 also indicates that there was limited change over the two years between 2013 and 2015. The changes observed have mainly involved a slight westerly extension to the sand/shingle barrier. This is in keeping with the observations made in Section 2.3 about the westerly movement of sand and shingle.

To take this analysis forward, ABPmer has examined the changing bed elevations using LiDAR survey data from 1999, 2013 and 2015. The results are shown in Figures 1 to 3. Figure 1 describes the latest topography of the site based on the 2015 LiDAR data, while Figure 2 shows the changes that have taken place over the 16 years between 1999 and 2015 (which includes the effects of Phases 5 and 6 when a total of around 87,750 m<sup>3</sup> of silt was recharged). These changes are described in Figure 2 as the differences in the vertical bed elevations between the two years (with red areas generally showing lower elevations over this period and blue areas generally showing higher bed levels). Using the same 'LiDAR-difference approach', Figure 3 then also describes the bed elevation changes between 2013 and 2015.
