Reuse of Sand from Sovereign Harbour Maintenance Dredging - 2017

1 Resolution of PBSC concerns

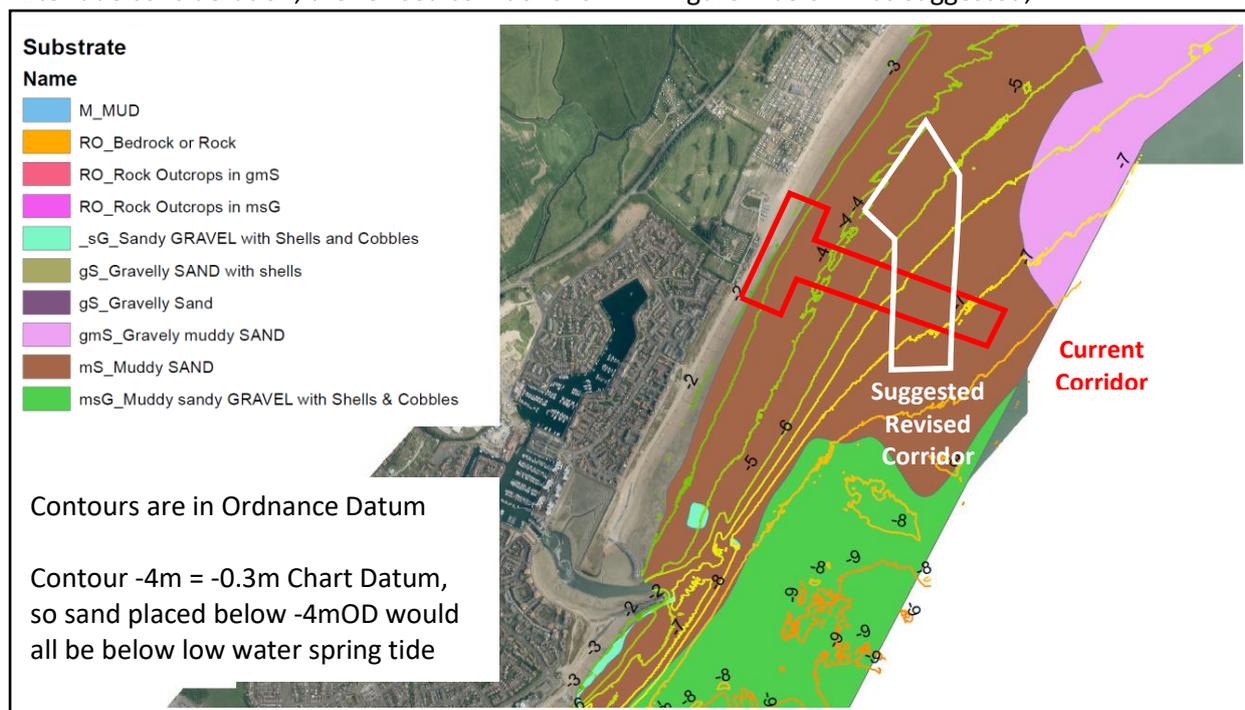
Figure 1: Suggested revised corridor for 2017

After due consideration, the revised corridor shown in Figure 4 below was suggested;

This image was emailed to PBSC Commodore Mark Doughty-Keen and President Gordon Bishop on 13th July and their response on 29th July 2016 confirmed the points in Section 1.3 above and that they had no objection to the proposed alternative.

This proposal was discussed with other stakeholders and consultees before precise coordinates were generated for a revised corridor and a request for a formal variation of PCDL's FEPA license being initiated.

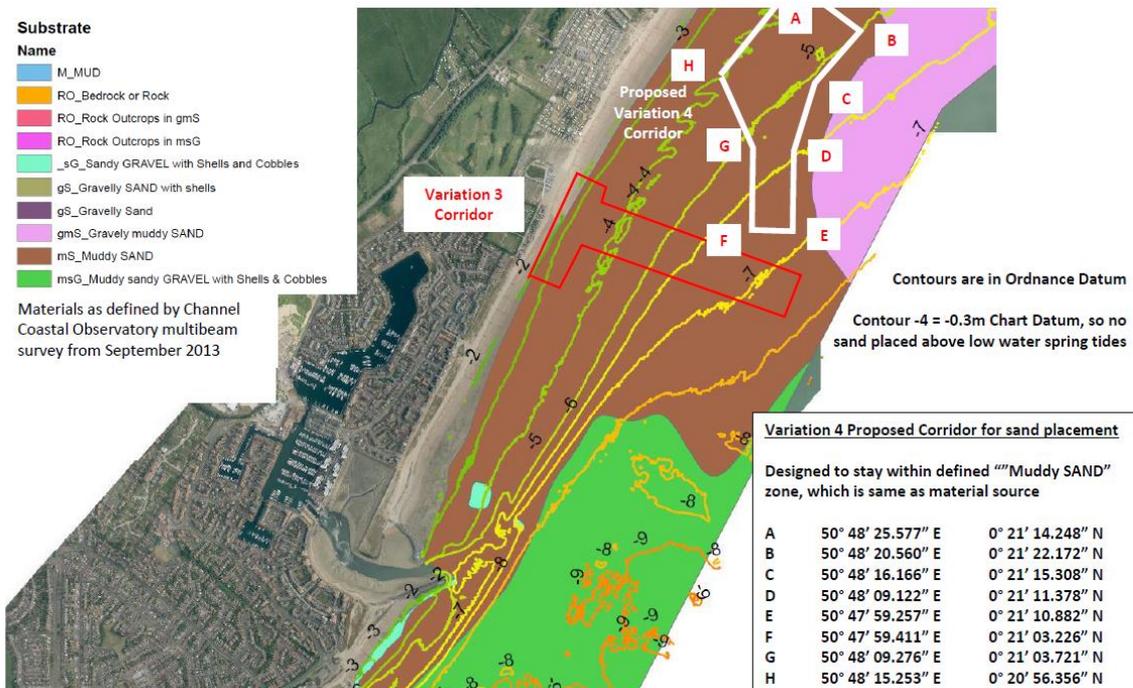
Figure 2: Fourth version of revised corridor to be used in 2017

Consequently, a fourth version was hurriedly proposed, moving the eastern and northeastern corridor extremities to within 100m of where the seabed sediment changed to “Gravelly muddy SAND”, essentially moving as far northeast as possible.

A variation to PCDL’s FEPA license 34001/080403/7 was issued on 5th May 2017.

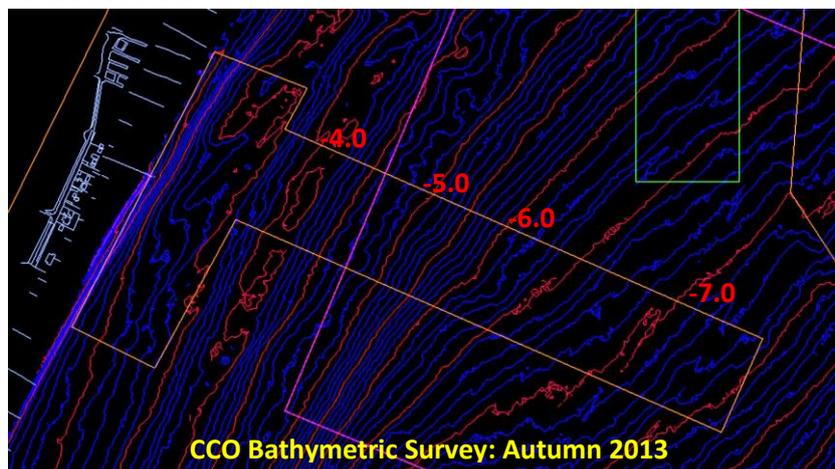
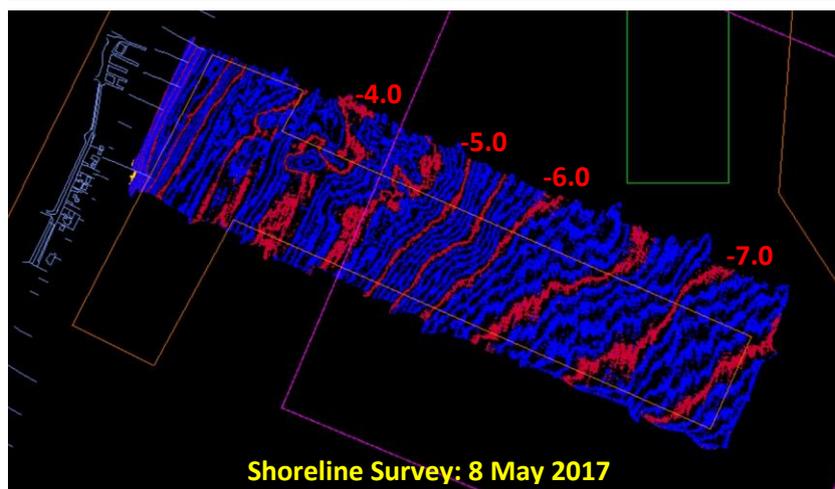
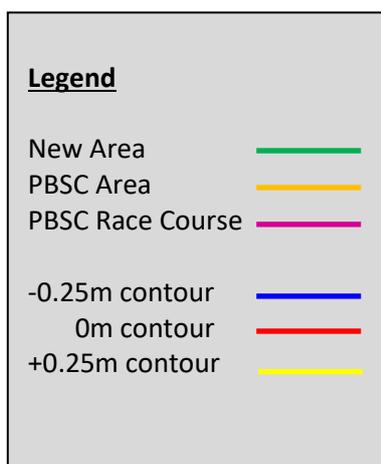
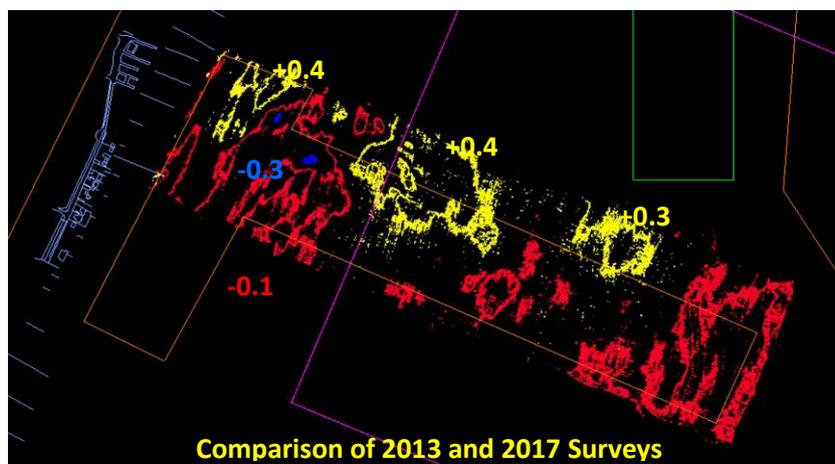
Figure 3: PBSC seabed surveys comparison 2013 - 2017

In order to ascertain changes through this period, base data from the Channel Coastal Observatory survey of autumn 2013 is compared to the July 2017 survey undertaken by Shoreline Surveys. Contour plots (0.1m interval) for both these surveys are shown, right, along with a comparison of height changes.

Monthly beach surveys taken over LW spring tides have always shown sand levels changing down to -3.5m at all times of the year. The 2013 survey shows a broad sand bar at -4.0m. Whilst the SW end of this doesn't seem to have changed much, the NE end shows an overall fall in seabed levels despite sand being added.

Landward of this, the intertidal sand bars will have formed, moved on and reformed many times during the intervening three years. A comparison of 2016 and 2017 surveys shows that the peaks formed as a result of 2016 sand placement had been smoothed by a year's worth of tides, with the highest points up to 0.7m lower than they were in summer 2016. In many cases the extent of this movement seems to have been relatively small. The level increase of +0.4m close to the -5.0m contour depth seems to suggest a northeasterly movement of only 100-200m. Perhaps more surprising is the +0.3m increase at the -6.5m contour

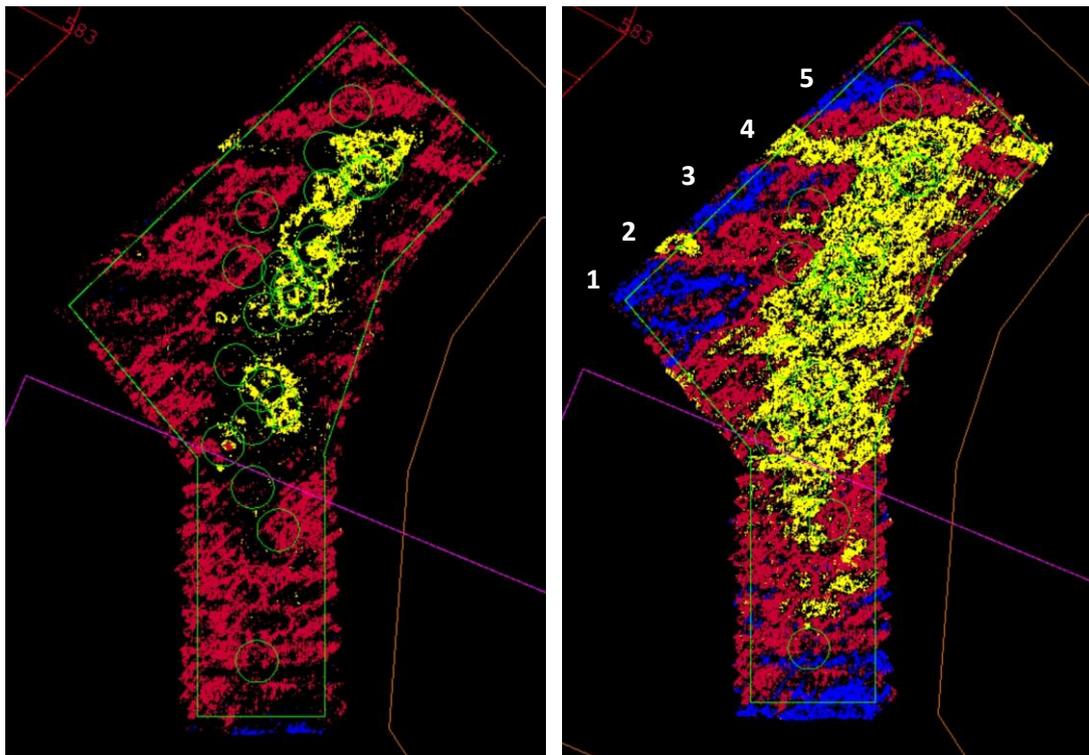
Figure 4: Comparison of Pre and Post sand placement at 'The Sandcastle' 2017

The two images above are of 'The Sandcastle' placement site, and both are comparative changes showing the difference between surveys before and after sand has been added. On the left the contour interval is 0.2m, whilst on the right it is 0.1m. Contour colours are similar to those used to illustrate sediment movement at PBSC, with blue showing a fall; red, no change; and yellow a rise in seabed levels.

Sand generated this year was half what it had been in 2016, and coupled with operational changes introduced to maximise the spread of material on the seabed, level changes were far lower than seen twelve months ago.
