Welwick Managed Realignment Scheme (England)

Case Study

March 2011

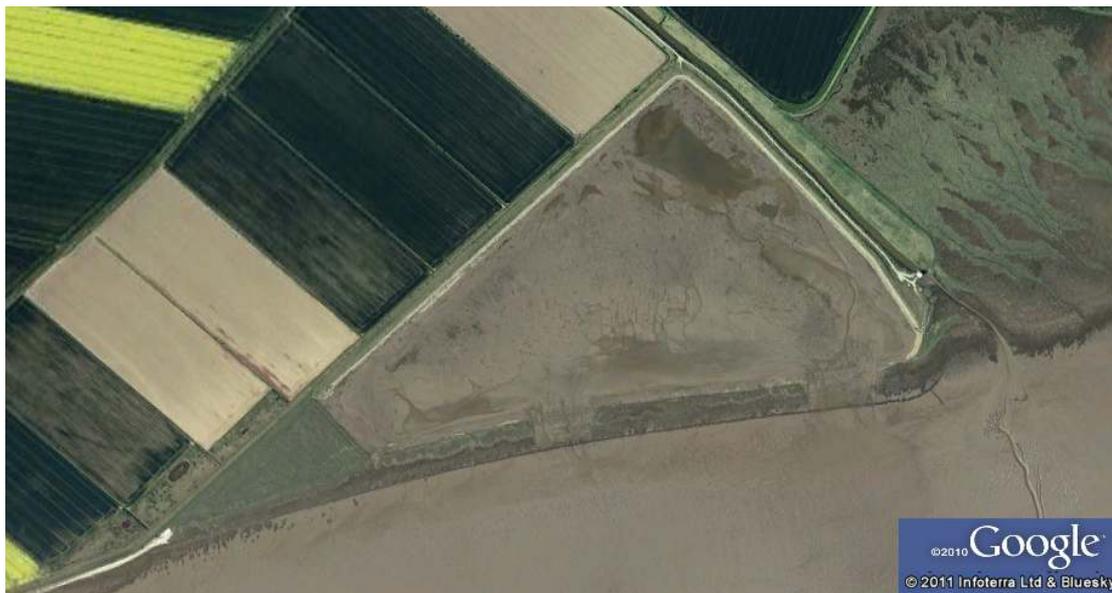
Plate 1. The managed realignment at Welwick - Google Earth derived aerial view

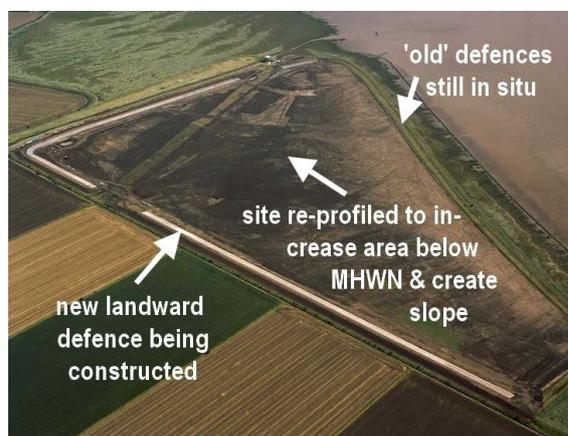
Plate 2: Rear embankment construction and re-profiling at Welwick in 2005

New flood defences were created at the rear of the 54ha Welwick site to a minimum height of 6.1m Ordnance Datum Newlyn (ODN); designed to withstand a 1 in 50 year design event. A strip of

saltmarsh was expected to develop in front of the new defences. The 70,000m³ of material needed for these defences was obtained from within the site from a combination of reprofiling and creation of temporary borrow pits. The new embankment was seeded and left to stabilise for one year.

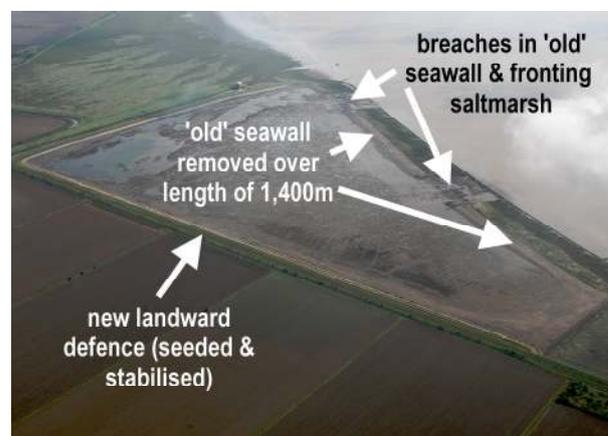
Plate 3: Welwick shortly after seawall removal (i.e. first inundation) in December 2006

The existing seawall was removed over a length of 1,400m, and the approximately 20,000m³ of material gained was used to fill the temporary borrow pits. The wholesale removal, rather than the creation of solitary breaches, was chosen for a number of reasons:

The old defence was removed in a series of stages: (1) removing the rear of the embankment, (2) the rock gabions, and (3) the overall lowering of the embankment. Following this, breaches were created in the existing saltmarsh in front of site. These were required as the fronting marsh is designated, and could thus not be removed completely to increase wave energy even further. As the typical elevation of this marsh was 3.2mODN, which coincides with the MHWN level, these breaches were necessary to allow the site to flood and drain sufficiently. The location of the breaches was chosen to minimise marsh losses (approximately 0.4ha). Their width had been assessed by calculating the discharge and considering the critical threshold for erosion of sediment. The suggested breach size was considered large enough for the velocities to be below the critical threshold for erosion.

With regards to the development of other habitats, there was a requirement to also create saltmarsh and grassland on site. By 2009, a proportion of the site had developed into saltmarsh, with the typical pioneer plants such as glasswort colonising within one year (see Plate 3). Other plants such as common saltmarsh grass, annual sea blite and common cord-grass have been slowly increasing in number. Thus, recognisable saltmarsh plant communities assembled relatively rapidly at Welwick; which was not unsurprising given the proximity of existing saltmarshes (and thus seed sources). With regards to grassland, this was mostly established on the new flood banks, and it appears to be developing the desired species composition. Breeding farmland birds have been found within this habitat. A total of 25 different species were observed during the latest survey undertaken in May 2009, including reed bunting, skylark and yellow wagtail.

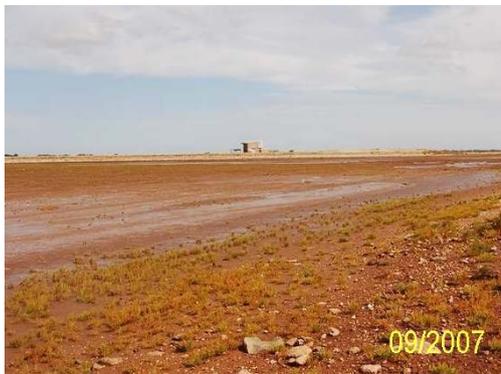
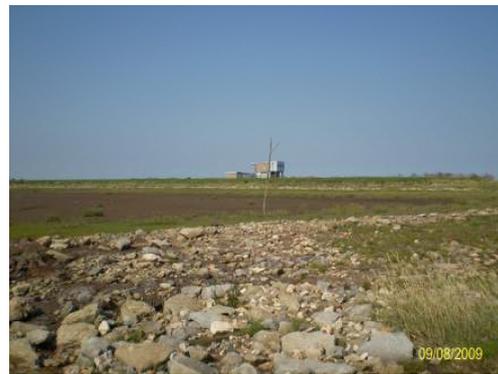
Plates 5 & 6. Marsh development in the eastern corner – 1 year on and 3 years on
