Nigg Bay Managed Realignment Scheme (Scotland)

Case Study

March 2011

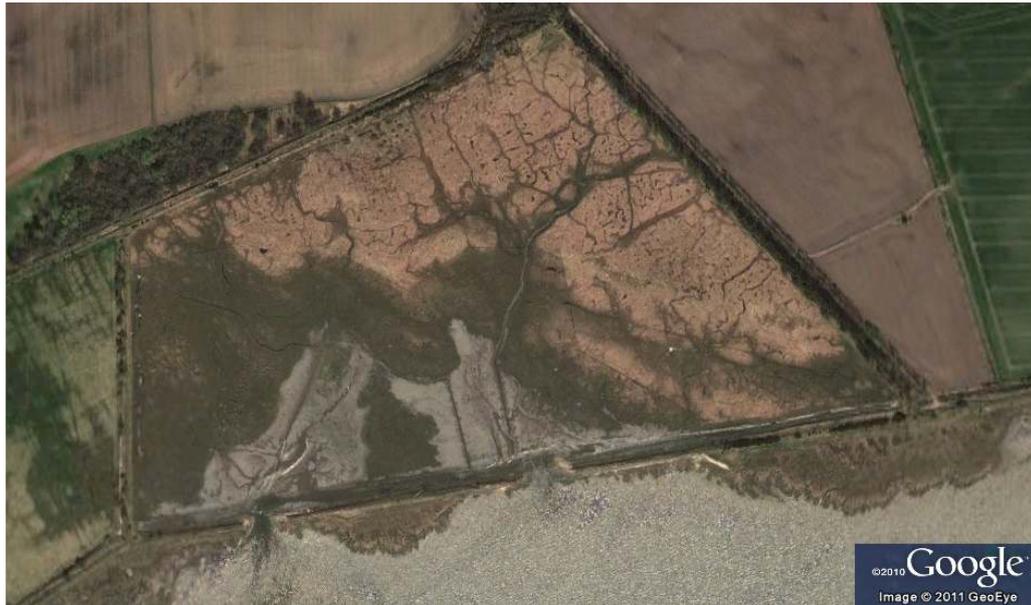
Plate 1. The managed realignment at Nigg Bay - Google Earth derived aerial view

This was the first planned realignment in Scotland and involved making two 20m-wide breaches in existing sea defences to allow the top of the tide to flood a 25ha field. This field was the last area of Nigg Bay to be land claimed (in the 1950s) and a secondary sea wall was already in place; this needed repairing and raising to a 1 in 50 year standard in advance of tidal inundation. The soils adjacent to the wall were suitable for use to build up the wall where required (on average by 10-20cm, over a length of 860m). The site was prepared by culverting drains which linked to adjacent fields, topping and grazing to reduce the amount of terrestrial vegetation, and the removal of trees. No internal earthworks were needed to create a creek system as a relict creek was still present. Approximately 2/3 of field is inundated at spring high water.

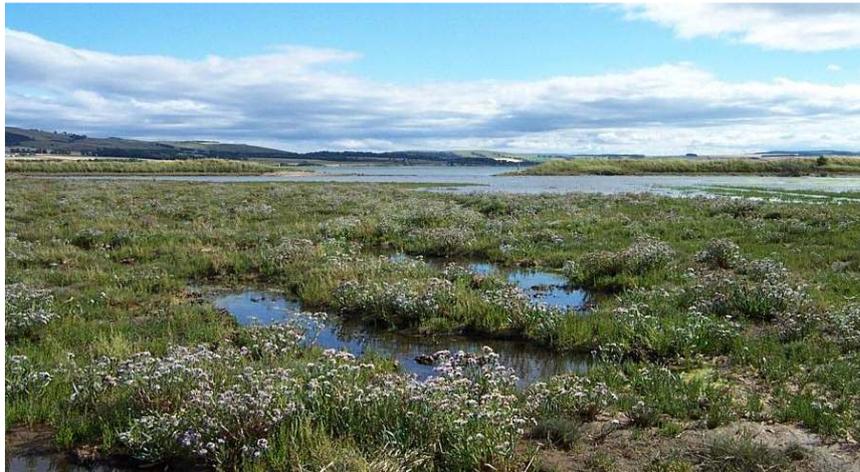
Plate 2. Sea aster in bloom; view across site towards one of the breaches

By 2005 the area had developed into three distinct zones: (i) an upper zone, which is rarely inundated and retains terrestrial grassland; (ii) an intermediate zone, which has been colonised by salt marsh species; and (iii) a lower zone, which experiences regular inundation and in which terrestrial grassland has been replaced by fine sediments. Nineteen species of waders and wildfowl were recorded using the site during winter 2004/05, the commonest of which were redshank (RSPB, 2005).
